Weekly Environmental Compliance Summary

Sudbury to Hudson Transmission Reliability Project (USEPA Tracking # MAR1003UW)

Week of: November 18, 2024 to November 22, 2024

CONSTRUCTION MONITORING REPORT

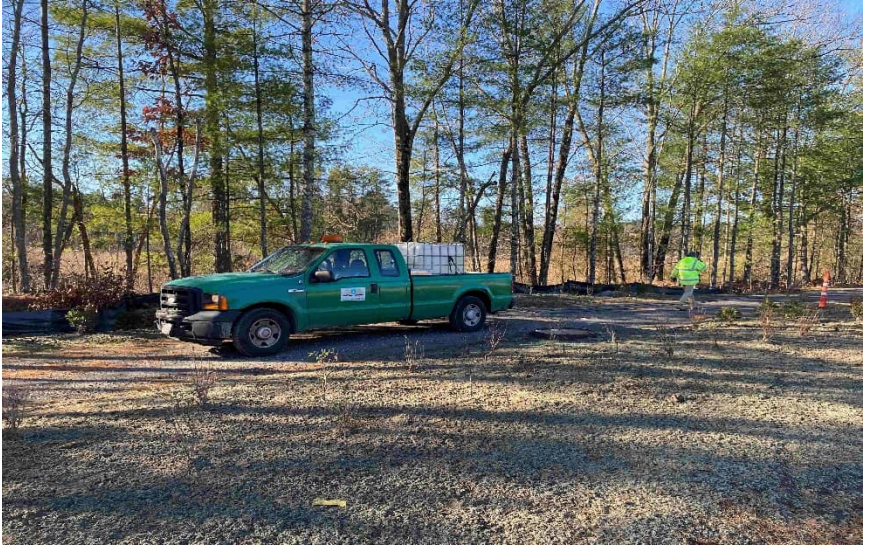
<p>PHOTOGRAPHIC LOG</p>	
<p>Client Name: Eversource</p>		<p>Site Location: Sudbury to Hudson Transmission Reliability Project</p>	<p>Town: Hudson</p>
<p>Photo No.: 4</p>	<p>Date: 11-18-24</p>

<p>Description:</p> <p>Work area within segment #3, manhole #8, MON watering plants, existing erosion control, looking westward.</p>

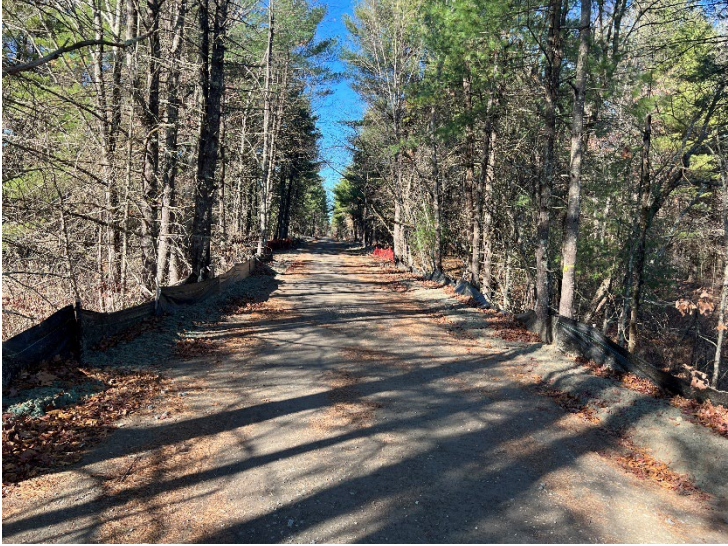
PHOTOGRAPHIC LOG	
Client Name: Eversource		Site Location: Sudbury to Hudson Transmission Reliability Project	Town: Sudbury
Photo No.: 8	Date: 11/18/2024

Description: View of E&S controls in segment 7. Facing west.

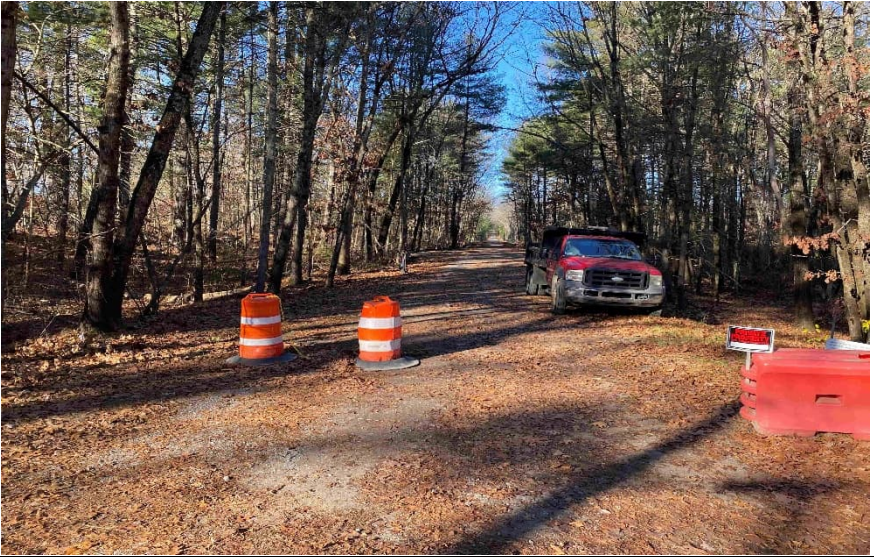
<p>PHOTOGRAPHIC LOG</p>	
<p>Client Name: Eversource</p>		<p>Site Location: Sudbury to Hudson Transmission Reliability Project</p>	<p>Town: Hudson</p>
<p>Photo No.: 5</p>	<p>Date: 11-20-24</p>

<p>Description:</p> <p>Work area within segment 5, ET&L equipment staged, existing erosion control, looking westward.</p>

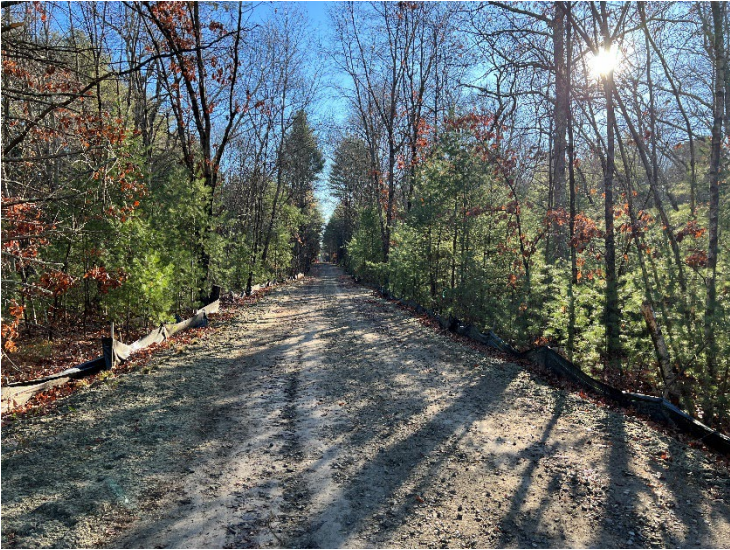
PHOTOGRAPHIC LOG	
Client Name: Eversource		Site Location: Sudbury to Hudson Transmission Reliability Project	Town: Sudbury
Photo No.: 1	Date: 11/20/2024

Description: View of E&S controls in segment 7. Facing east.

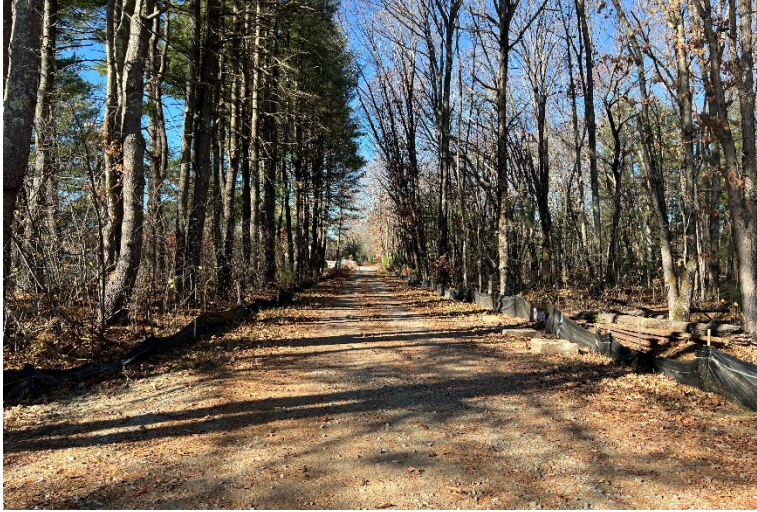
PHOTOGRAPHIC LOG	
Client Name: Eversource		Site Location: Sudbury to Hudson Transmission Reliability Project	Town: Sudbury
Photo No.: 3	Date: 11/20/2024

Description: View of E&S controls in segment 11 at Diamond Junction. Facing west.

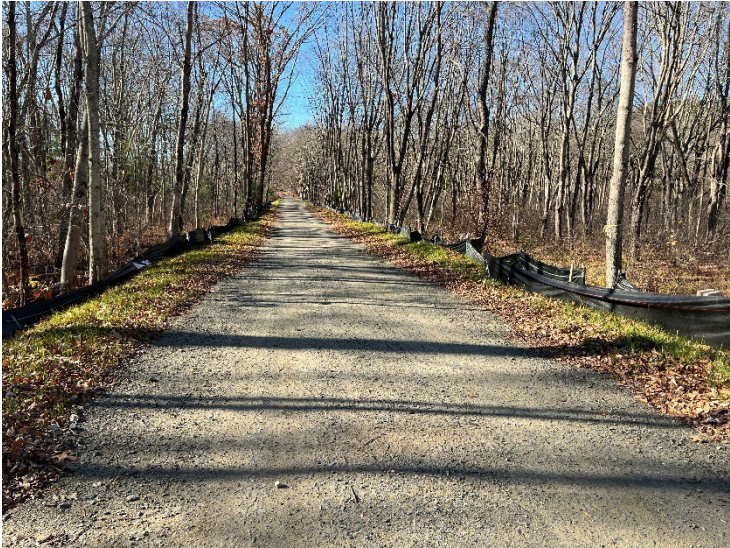
PHOTOGRAPHIC LOG	
Client Name: Eversource		Site Location: Sudbury to Hudson Transmission Reliability Project	Town: Sudbury
Photo No.: 7	Date: 11/20/2024

Description: View of E&S controls in segment 14. Facing west.

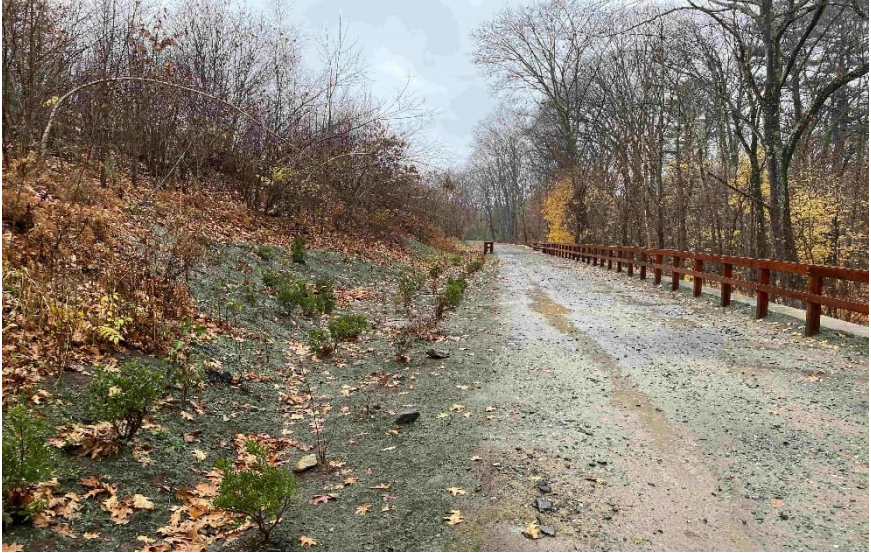
<p>PHOTOGRAPHIC LOG</p>	
<p>Client Name: Eversource</p>		<p>Site Location: Sudbury to Hudson Transmission Reliability Project</p>	<p>Town: Hudson</p>
<p>Photo No.: 1</p>	<p>Date: 11-21-24</p>

<p>Description:</p> <p>Work area within segment 1, manhole #6, area recently planted & hydro seeded, looking westward.</p>

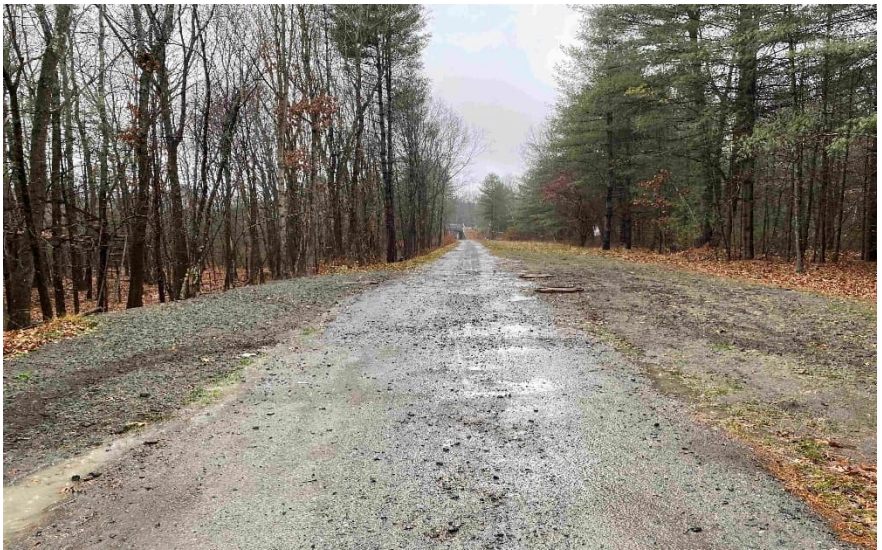
<p>PHOTOGRAPHIC LOG</p>	
<p>Client Name: Eversource</p>		<p>Site Location: Sudbury to Hudson Transmission Reliability Project</p>	<p>Town: Hudson</p>
<p>Photo No.: 4</p>	<p>Date: 11-21-24</p>

<p>Description:</p> <p>Work area within segment 2, manhole #7, area recently hydro seeded, looking westward.</p>

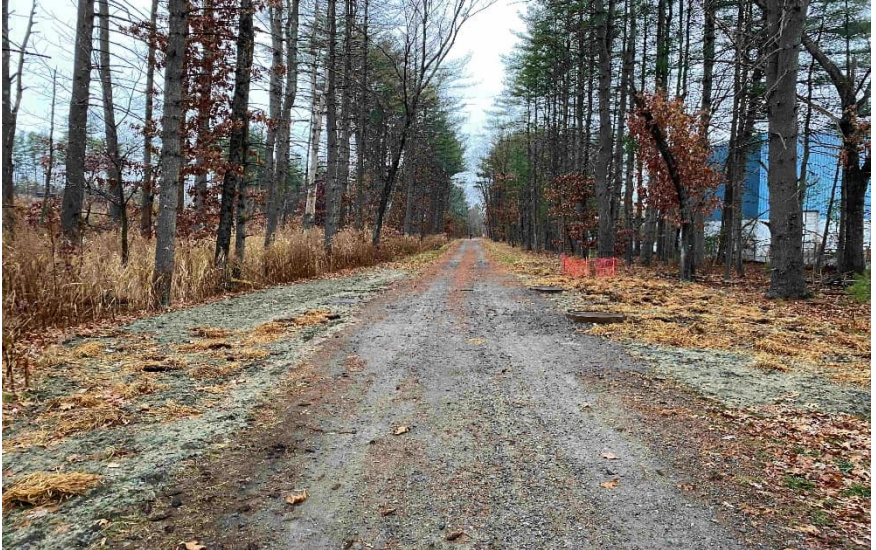
<p>PHOTOGRAPHIC LOG</p>	
<p>Client Name: Eversource</p>		<p>Site Location: Sudbury to Hudson Transmission Reliability Project</p>	<p>Town: Hudson</p>
<p>Photo No.: 6</p>	<p>Date: 11-21-24</p>

<p>Description:</p> <p>Work area within segment 4, manhole #10, area recently hydroseeded, looking westward.</p>

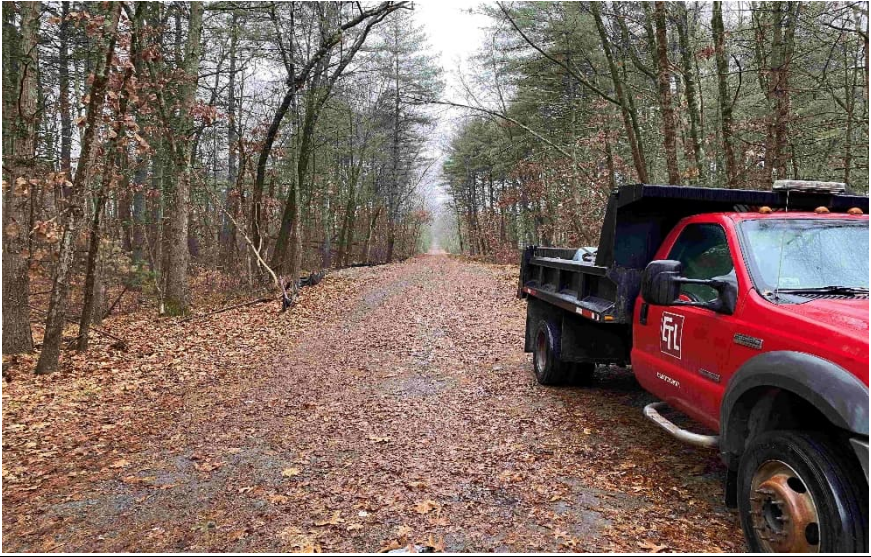
<p>PHOTOGRAPHIC LOG</p>	
<p>Client Name: Eversource</p>		<p>Site Location: Sudbury to Hudson Transmission Reliability Project</p>	<p>Town: Hudson</p>
<p>Photo No.: 7</p>	<p>Date: 11-21-24</p>

<p>Description:</p> <p>Work area within segment 5, manhole #13, ET&L equipment staged, area recently hydroseeded, looking westward.</p>

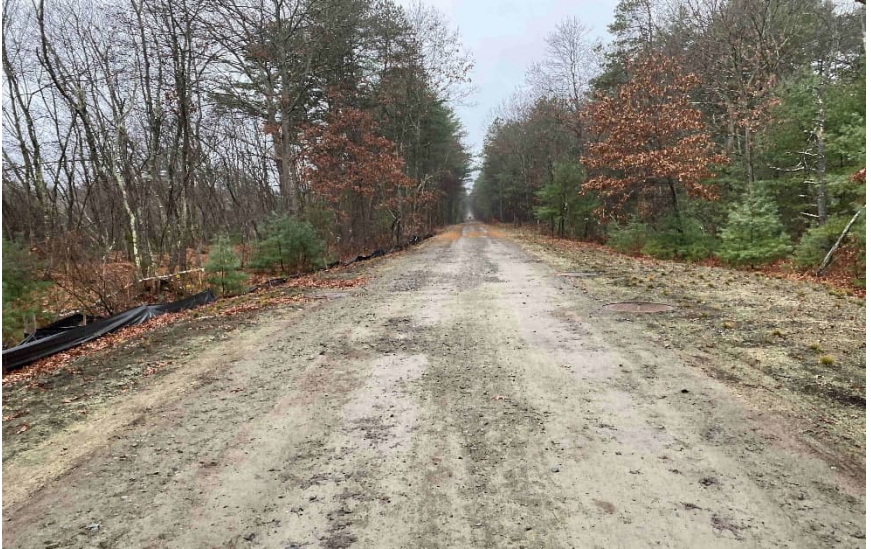
<p>PHOTOGRAPHIC LOG</p>	
<p>Client Name: Eversource</p>		<p>Site Location: Sudbury to Hudson Transmission Reliability Project</p>	<p>Town: Hudson</p>
<p>Photo No.: 8</p>	<p>Date: 11-21-24</p>

<p>Description:</p> <p>Work area within segment 6, manhole #14, area recently planted & hydroseeded, looking westward.</p>

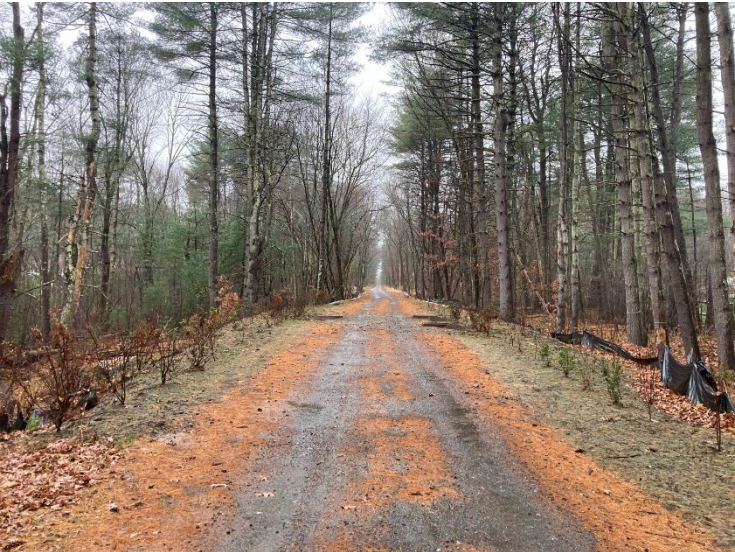
PHOTOGRAPHIC LOG	
Client Name: Eversource		Site Location: Sudbury to Hudson Transmission Reliability Project	Town: Sudbury
Photo No.: 2	Date: 11/21/2024

Description: View of E&S controls and plantings at MH #19 in segment 9. Facing west.

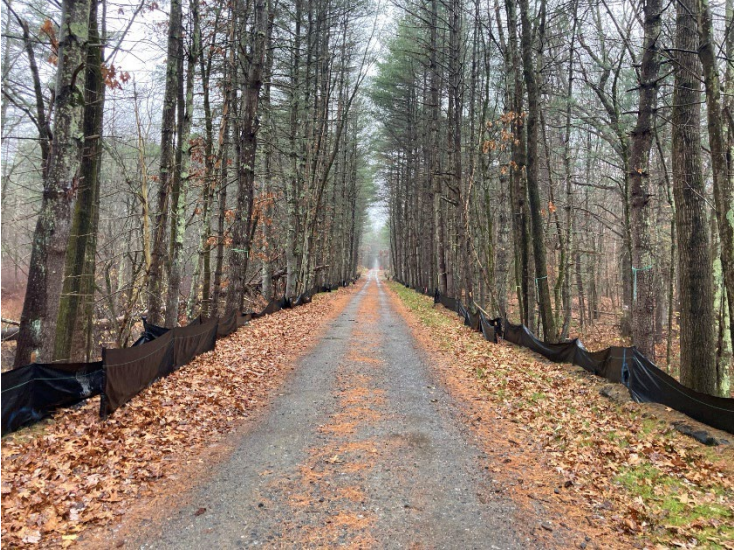
PHOTOGRAPHIC LOG	
Client Name: Eversource		Site Location: Sudbury to Hudson Transmission Reliability Project	Town: Sudbury
Photo No.: 3	Date: 11/21/2024

Description: View of E&S controls in segment 10. Facing west.

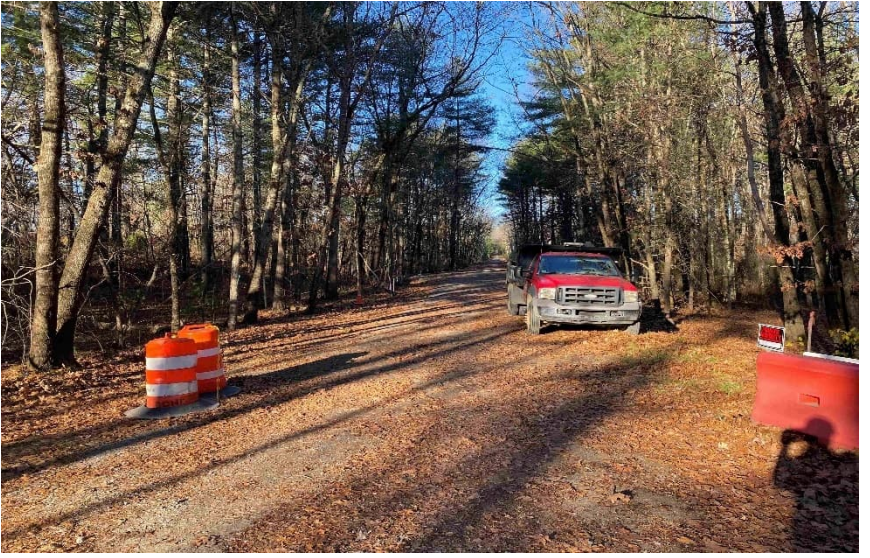
PHOTOGRAPHIC LOG	
Client Name: Eversource		Site Location: Sudbury to Hudson Transmission Reliability Project	Town: Hudson
Photo No.: 7	Date: 11-19-24

Description: Work area within segment 5, ET&L equipment staged, existing erosion control, looking westward.

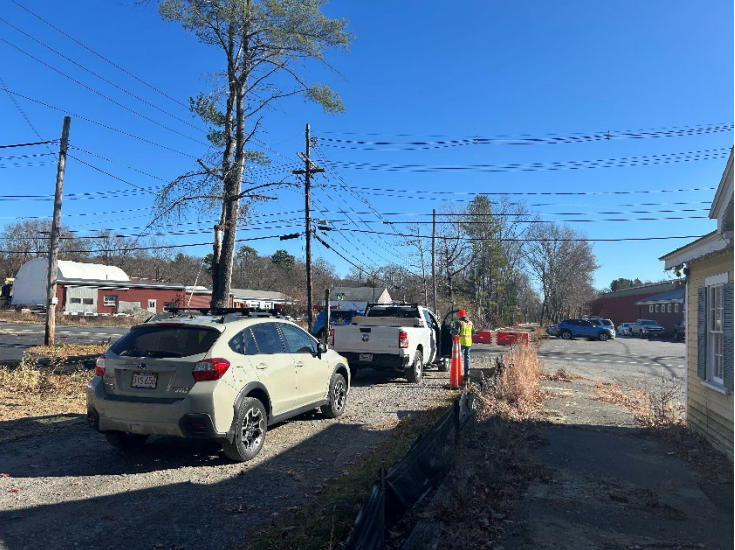
PHOTOGRAPHIC LOG	
Client Name: Eversource		Site Location: Sudbury to Hudson Transmission Reliability Project	Town: Sudbury
Photo No.: 2	Date: 11-19-24

Description: View of Bond conducting as-built survey in segment 11. Facing east.

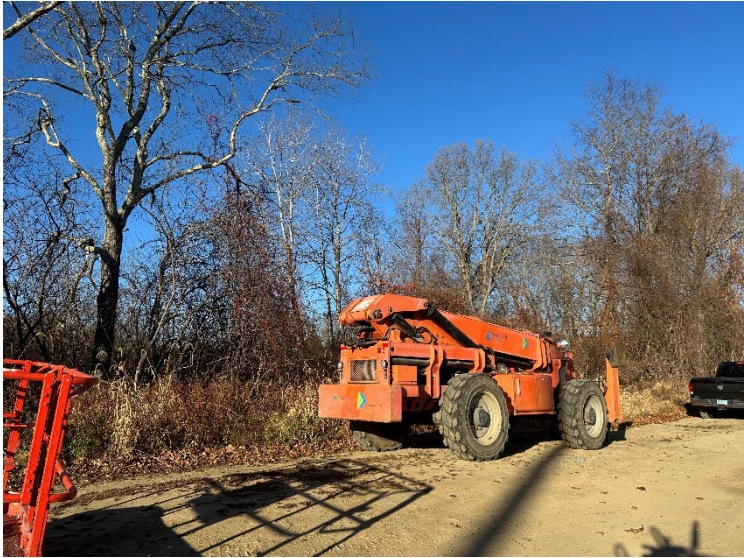
Epsilon ASSOCIATES INC.		PHOTOGRAPHIC LOG	
Client Name: Eversource		Site Location: Sudbury to Hudson Transmission Reliability Project	Town: Sudbury
Photo No.: 3	Date: 11-19-24

Description: View of Haugland equipment staging at the Sudbury substation. Facing northwest.

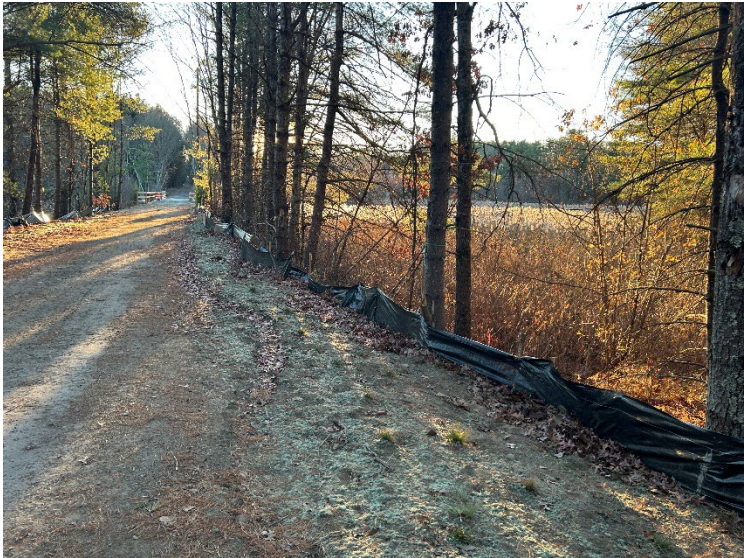
Epsilon ASSOCIATES INC.		PHOTOGRAPHIC LOG	
Client Name: Eversource		Site Location: Sudbury to Hudson Transmission Reliability Project	Town: Sudbury
Photo No.: 4	Date: 11-19-24

Description: View of E&S controls within segment 7. Facing east.

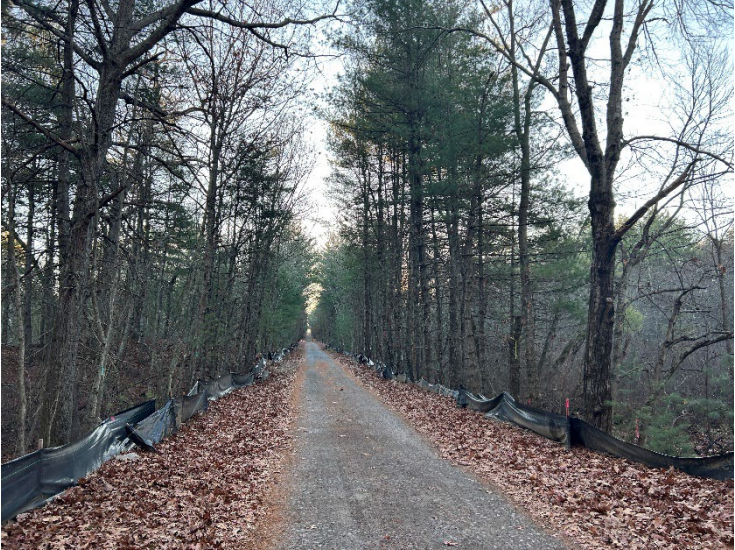
PHOTOGRAPHIC LOG	
Client Name: Eversource		Site Location: Sudbury to Hudson Transmission Reliability Project	Town: Sudbury
Photo No.: 5	Date: 11-19-24

Description: View of E&S controls within segment 8. Facing east.

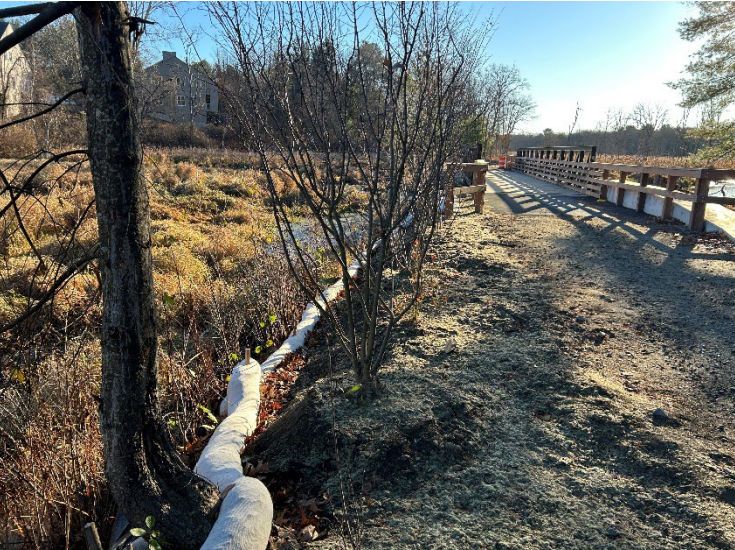
PHOTOGRAPHIC LOG	
Client Name: Eversource		Site Location: Sudbury to Hudson Transmission Reliability Project	Town: Sudbury
Photo No.: 6	Date: 11-19-24

Description: View of compost filter tubes at bridge 127. Facing east.

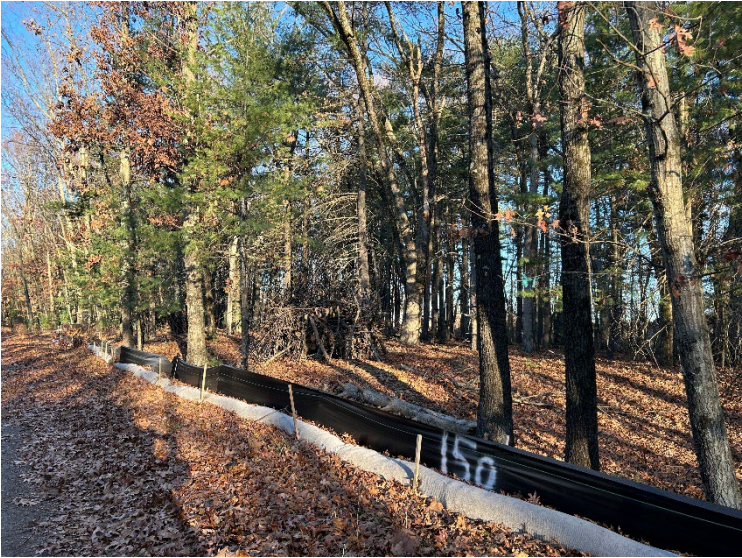
Epsilon ASSOCIATES INC.		PHOTOGRAPHIC LOG	
Client Name: Eversource		Site Location: Sudbury to Hudson Transmission Reliability Project	Town: Sudbury
Photo No.: 7	Date: 11-19-24

Description: View of E&S controls and brush pile installed in segment 11. Facing northwest.

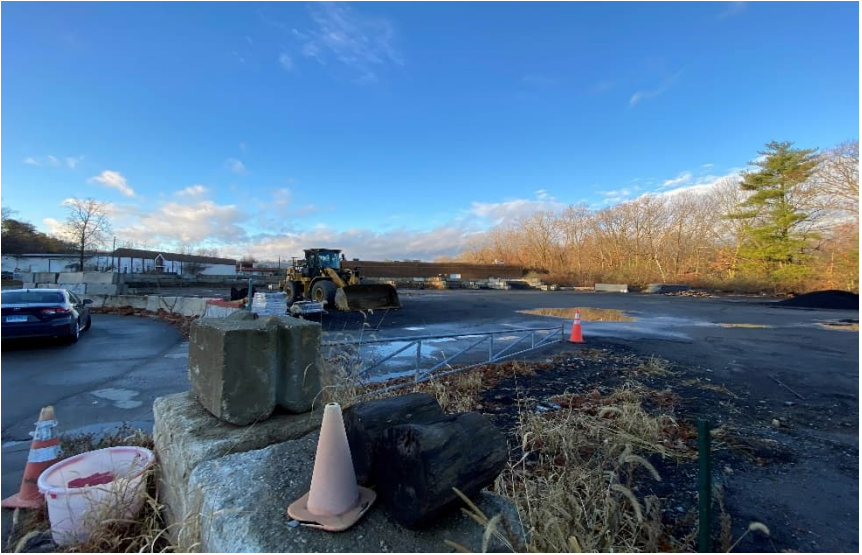
PHOTOGRAPHIC LOG	
Client Name: Eversource		Site Location: Sudbury to Hudson Transmission Reliability Project	Town: Hudson
Photo No.: 3	Date: 11-22-24

Description: Bonazzoli laydown yard, Bond equipment staged here, looking westward.

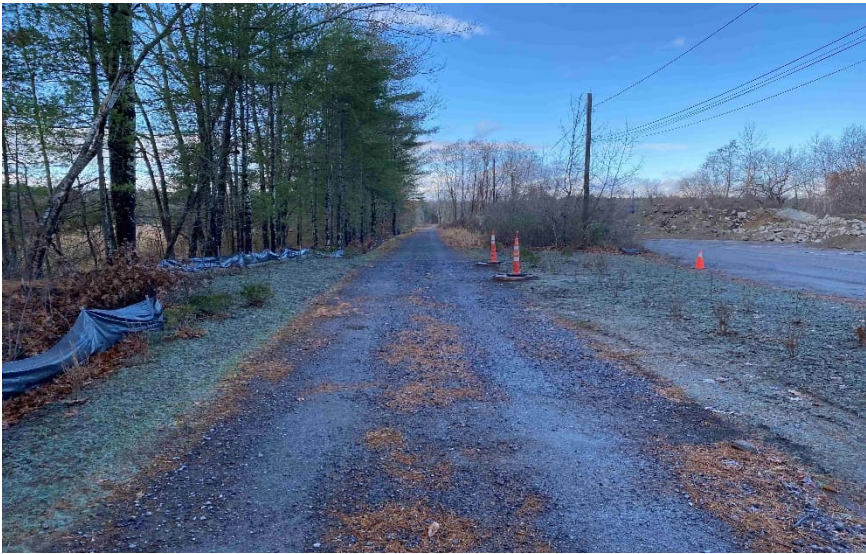
PHOTOGRAPHIC LOG	
Client Name: Eversource		Site Location: Sudbury to Hudson Transmission Reliability Project	Town: Hudson
Photo No.: 4	Date: 11-22-24

Description: Work area within segment 3, manhole #8, area recently planted & hydro seeded, existing erosion control, looking westward.

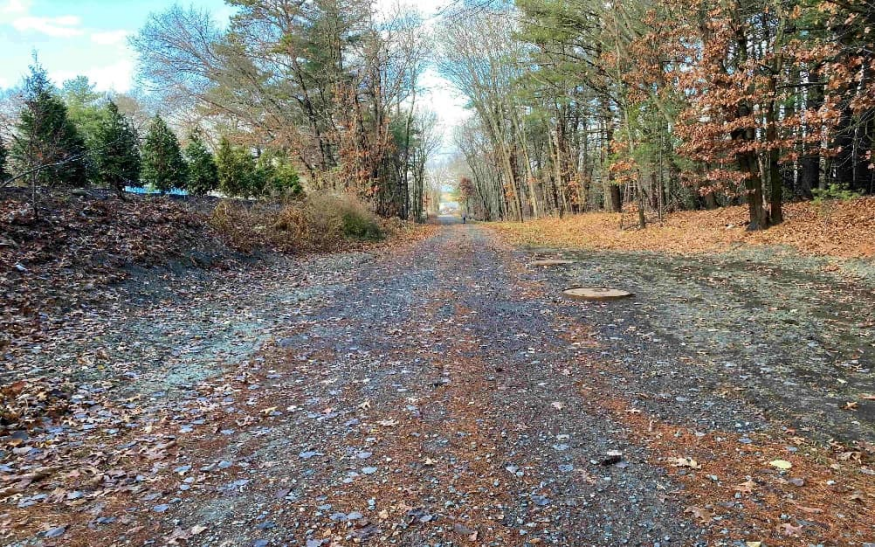
PHOTOGRAPHIC LOG	
Client Name: Eversource		Site Location: Sudbury to Hudson Transmission Reliability Project	Town: Hudson
Photo No.: 5	Date: 11-22-24

Description: Work area within segment 3, manhole #9, area recently hydro seeded, existing erosion control, looking westward.

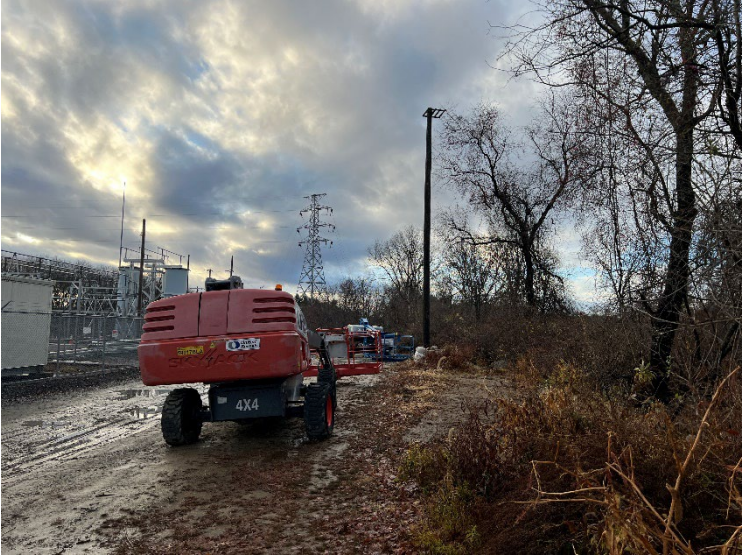
PHOTOGRAPHIC LOG	
Client Name: Eversource		Site Location: Sudbury to Hudson Transmission Reliability Project	Town: Sudbury
Photo No.: 3	Date: 11/22/2024

Description: View of United Rentals equipment staging at the Sudbury substation. Facing south.

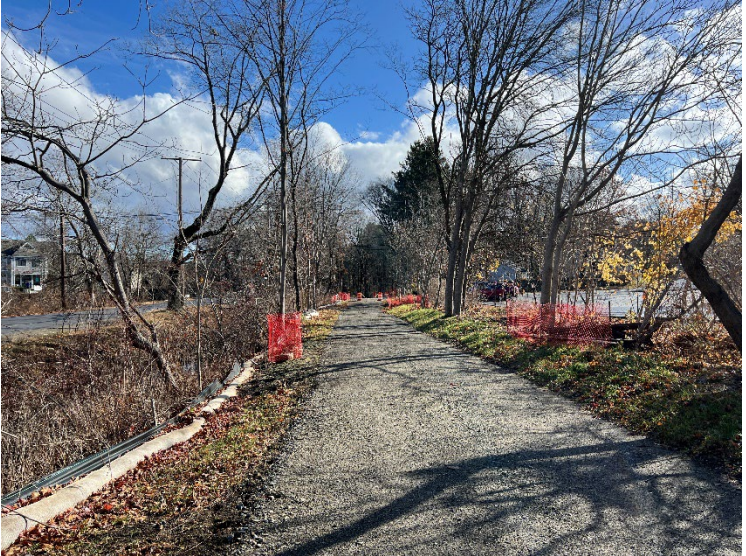
PHOTOGRAPHIC LOG	
Client Name: Eversource		Site Location: Sudbury to Hudson Transmission Reliability Project	Town: Sudbury
Photo No.: 4	Date: 11/22/2024

Description: View of E&S controls within segment 12. Facing east.

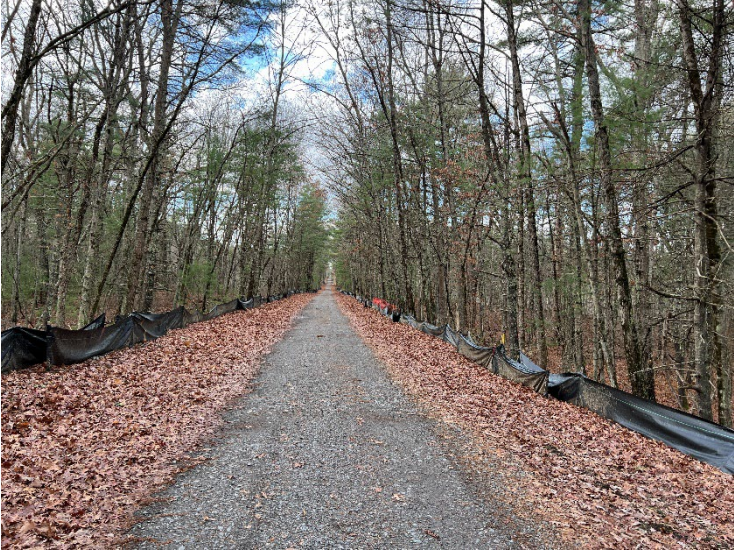
PHOTOGRAPHIC LOG	
Client Name: Eversource		Site Location: Sudbury to Hudson Transmission Reliability Project	Town: Sudbury
Photo No.: 5	Date: 11/22/2024

Description: View of E&S controls within segment 8. Facing west.

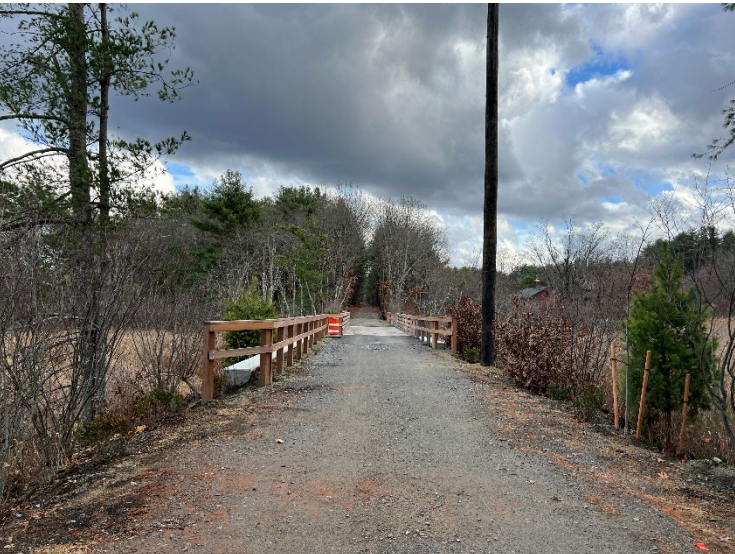
PHOTOGRAPHIC LOG	
Client Name: Eversource		Site Location: Sudbury to Hudson Transmission Reliability Project	Town: Sudbury
Photo No.: 6	Date: 11/22/2024

Description: View of Bridge 128. Facing east.

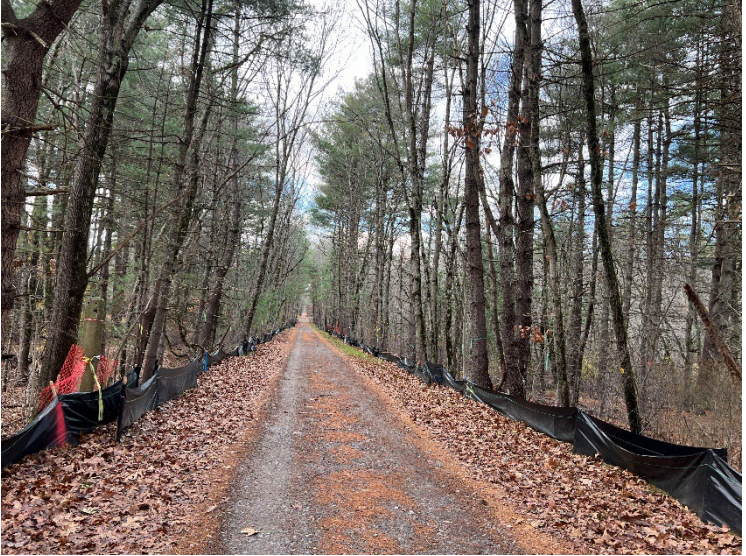
PHOTOGRAPHIC LOG	
Client Name: Eversource		Site Location: Sudbury to Hudson Transmission Reliability Project	Town: Sudbury
Photo No.: 7	Date: 11/22/2024

Description: View of E&S controls in segment 10. Facing west.
