Weekly Environmental Compliance Summary

Sudbury to Hudson Transmission Reliability Project (USEPA Tracking # MAR1003UW)

Week of: November 25, 2024 to November 29, 2024

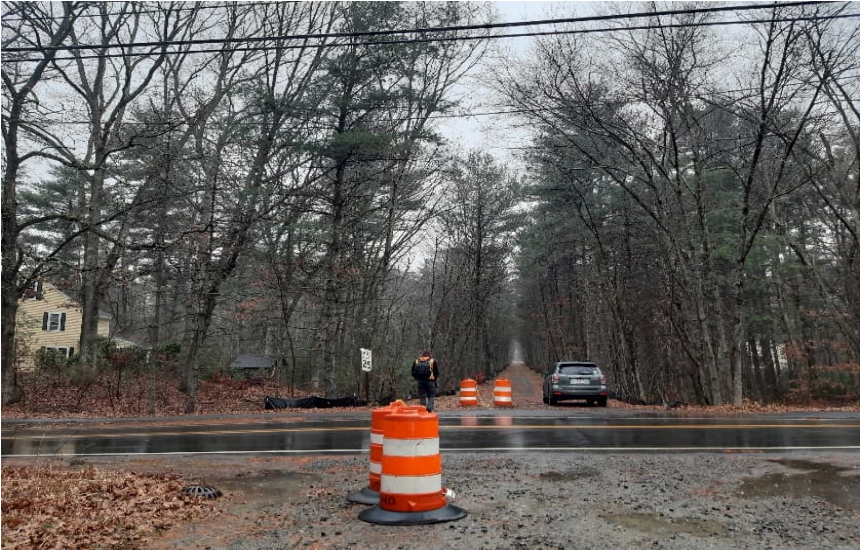
<p>PHOTOGRAPHIC LOG</p>	
<p>Client Name: Eversource</p>		<p>Site Location: Sudbury to Hudson Transmission Reliability Project</p>	<p>Town: Sudbury</p>
<p>Photo No.: 5</p>	<p>Date: 11-26-24</p>

<p>Description:</p> <p>Segments 10 and 9, SWCA transiting between cold-water fishery locations, looking westward.</p>

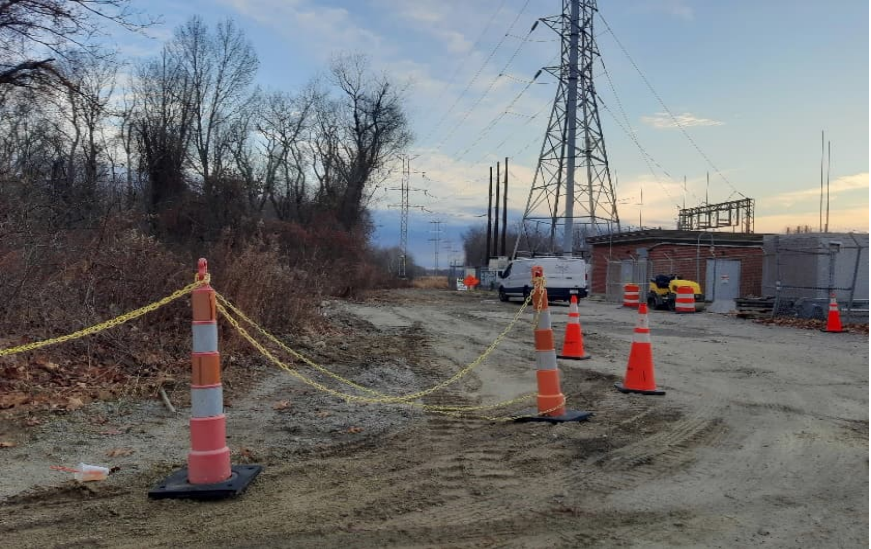
<p>PHOTOGRAPHIC LOG</p>	
<p>Client Name: Eversource</p>		<p>Site Location: Sudbury to Hudson Transmission Reliability Project</p>	<p>Town: Sudbury</p>
<p>Photo No.: 8</p>	<p>Date: 11-26-24</p>

<p>Description:</p> <p>Sudbury Substation, adjacent to Segment 14, work area for activities unrelated to project. Looking eastward.</p>

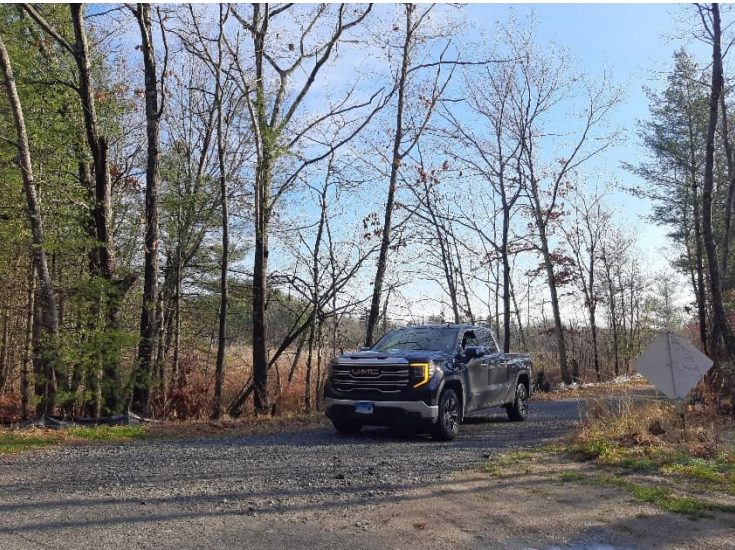
<p>PHOTOGRAPHIC LOG</p>	
<p>Client Name: Eversource</p>		<p>Site Location: Sudbury to Hudson Transmission Reliability Project</p>	<p>Town: Hudson</p>
<p>Photo No.: 6</p>	<p>Date: 11-27-24</p>

<p>Description:</p> <p>Segment 2, Eversource inspecting ROW, looking westward.</p>

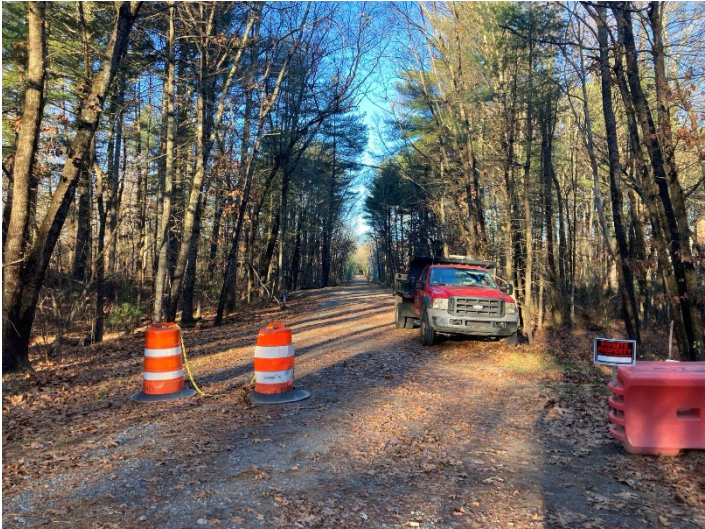
Epsilon ASSOCIATES INC.		PHOTOGRAPHIC LOG	
Client Name: Eversource		Site Location: Sudbury to Hudson Transmission Reliability Project	Town: Hudson
Photo No.: 5	Date: 11-25-2024

Description: View of ET&L equipment staged in segment 5. Facing west.

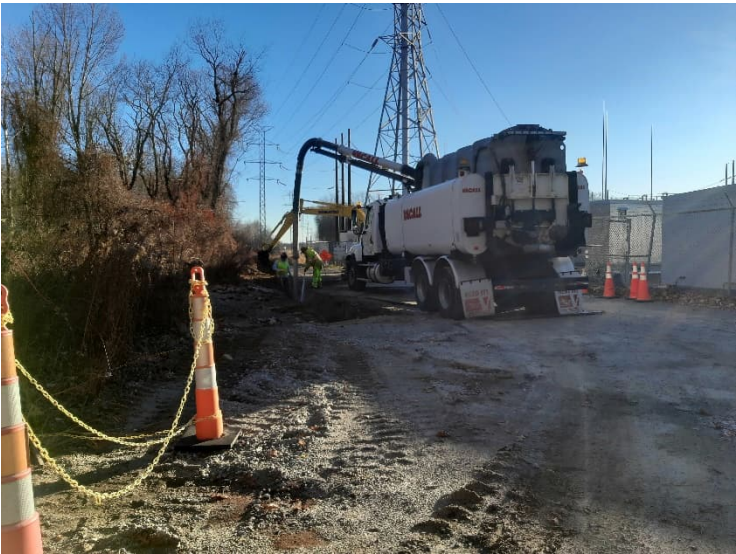
PHOTOGRAPHIC LOG	
Client Name: Eversource		Site Location: Sudbury to Hudson Transmission Reliability Project	Town: Sudbury
Photo No.: 8	Date: 11-25-24

Description: Sudbury substation, adjacent to Segment 14, work unrelated to project. Looking eastward.
