Weekly Environmental Compliance Summary

Sudbury to Hudson Transmission Reliability Project (USEPA Tracking # MAR1003UW)

Week of: December 2, 2024 to December 7, 2024

CONSTRUCTION MONITORING REPORT

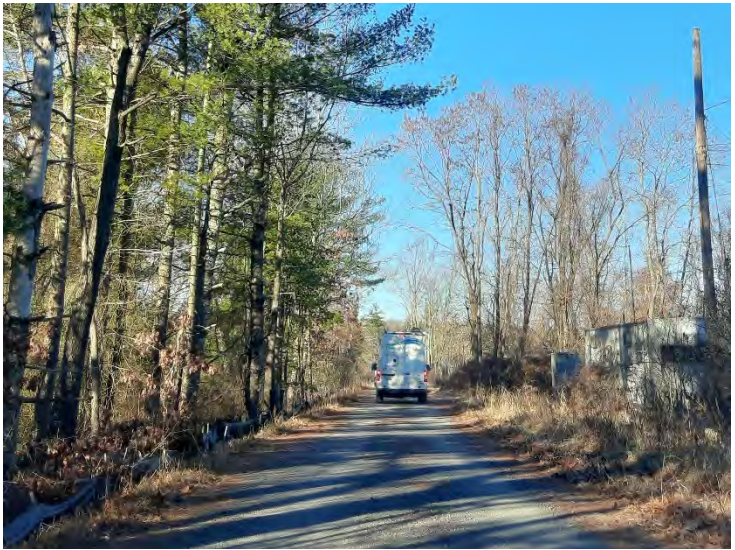
<p align="center">PHOTOGRAPHIC LOG</p>	
<p>Client Name: Eversource</p>		<p>Site Location: Sudbury to Hudson Transmission Reliability Project</p>	<p>Town: Hudson</p>
<p>Photo No.: 2</p>	<p>Date: 12-4-24</p>

<p>Description:</p> <p>Segment 3, New Wave checking handholes for slack bag installation, looking westward.</p>

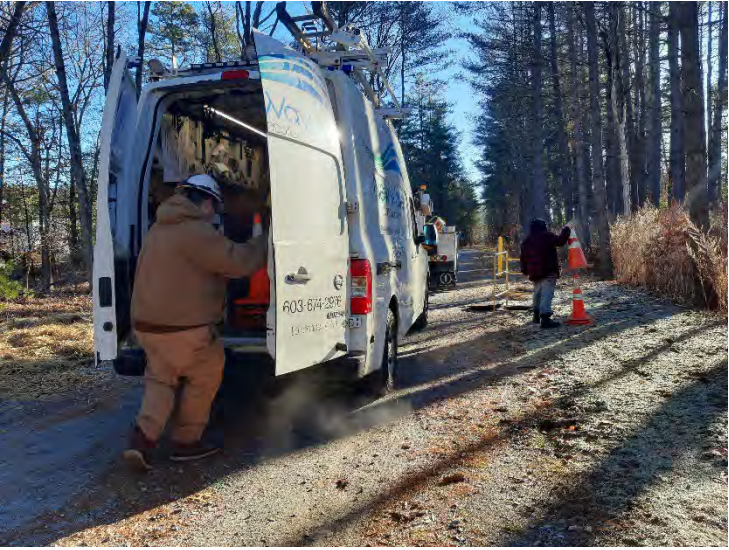
<p>PHOTOGRAPHIC LOG</p>	
<p>Client Name: Eversource</p>		<p>Site Location: Sudbury to Hudson Transmission Reliability Project</p>	<p>Town: Hudson</p>
<p>Photo No.: 3</p>	<p>Date: 12-4-24</p>

<p>Description:</p> <p>Segment 4, handhole #10 (HH10), New Wave placing fiber optic cable slack in slack bag, looking eastward.</p>

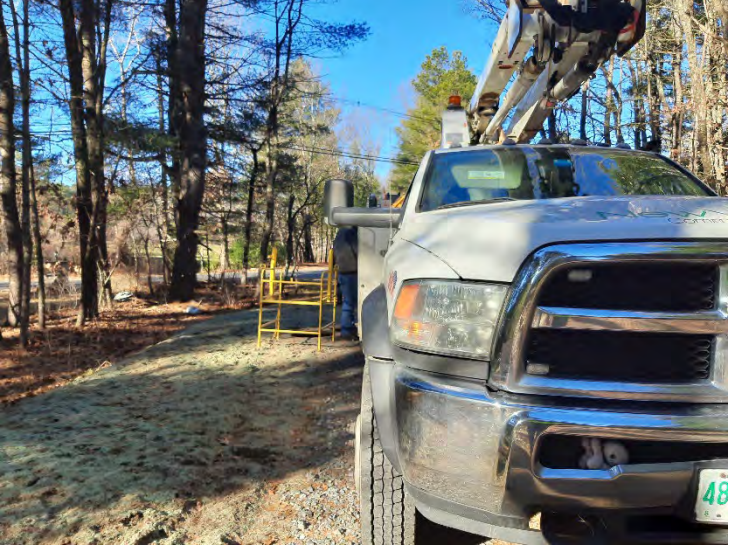
<p>PHOTOGRAPHIC LOG</p>	
<p>Client Name: Eversource</p>		<p>Site Location: Sudbury to Hudson Transmission Reliability Project</p>	<p>Town: Hudson</p>
<p>Photo No.: 4</p>	<p>Date: 12-4-24</p>

<p>Description:</p> <p>Segment 5, HH11, New Wave placing fiber optic cable slack in slack bag, looking westward.</p>

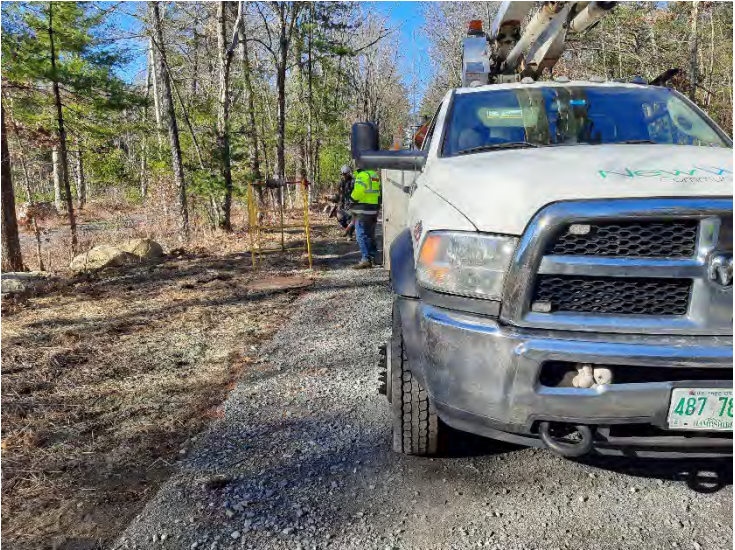
<p>PHOTOGRAPHIC LOG</p>	
<p>Client Name: Eversource</p>		<p>Site Location: Sudbury to Hudson Transmission Reliability Project</p>	<p>Town: Hudson</p>
<p>Photo No.: 5</p>	<p>Date: 12-4-24</p>

<p>Description:</p> <p>Segment 5, HH12, New Wave placing fiber optic cable slack in slack bag, looking westward.</p>

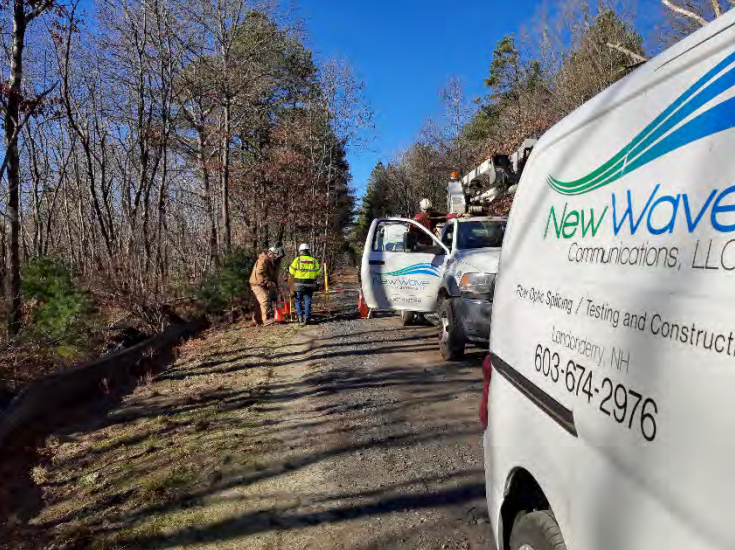
<p>PHOTOGRAPHIC LOG</p>	
<p>Client Name: Eversource</p>		<p>Site Location: Sudbury to Hudson Transmission Reliability Project</p>	<p>Town: Hudson</p>
<p>Photo No.: 6</p>	<p>Date: 12-4-24</p>

<p>Description:</p> <p>Segment 6, HH14, ET&L placing fiber optic cable slack in slack bag, looking westward.</p>

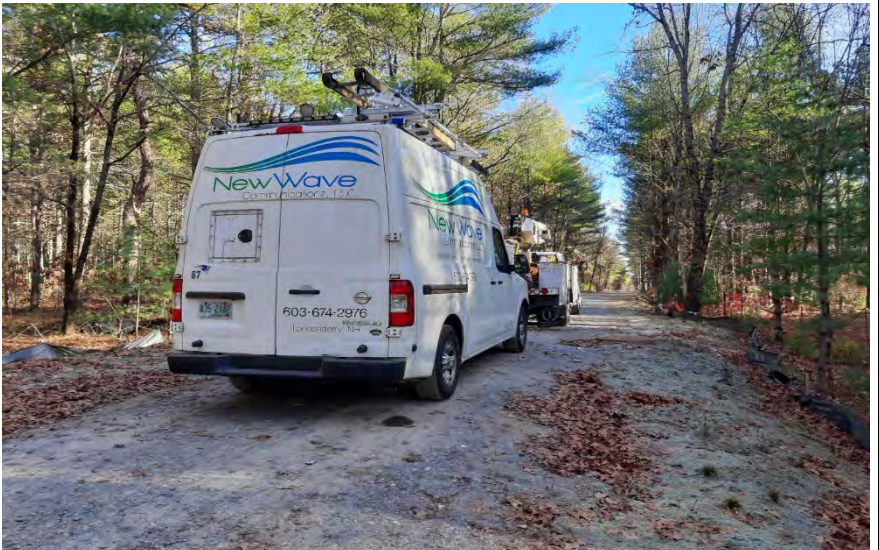
<p>PHOTOGRAPHIC LOG</p>	
<p>Client Name: Eversource</p>		<p>Site Location: Sudbury to Hudson Transmission Reliability Project</p>	<p>Town: Sudbury</p>
<p>Photo No.: 2</p>	<p>Date: 12-4-24</p>

<p>Description:</p> <p>New Wave working within segment 7, handhole 15 area, existing erosion control, looking eastward. Photo courtesy of Mary Toner (AECOM).</p>

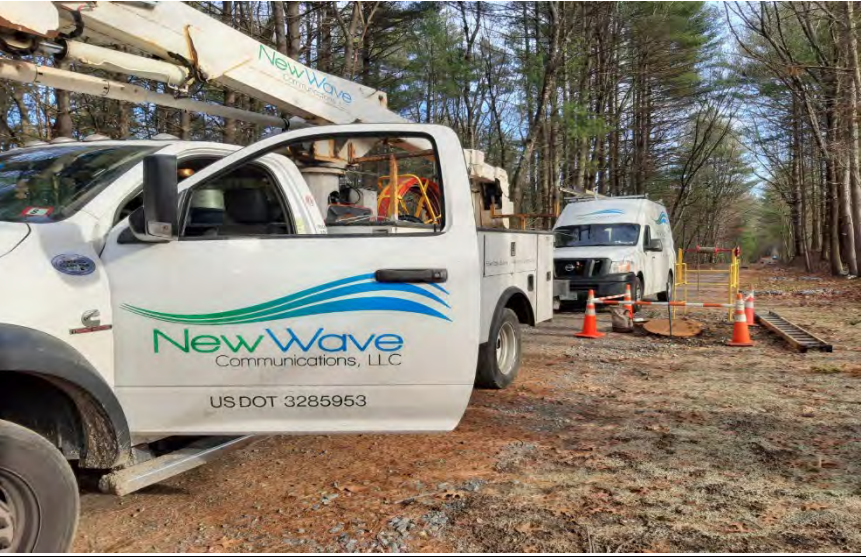
<p>PHOTOGRAPHIC LOG</p>	
<p>Client Name: Eversource</p>		<p>Site Location: Sudbury to Hudson Transmission Reliability Project</p>	<p>Town: Sudbury</p>
<p>Photo No.: 3</p>	<p>Date: 12-4-24</p>

<p>Description:</p> <p>New Wave working within segment 8, at handhole 17, existing erosion control, looking eastward. Photo courtesy of Mary Toner (AECOM).</p>

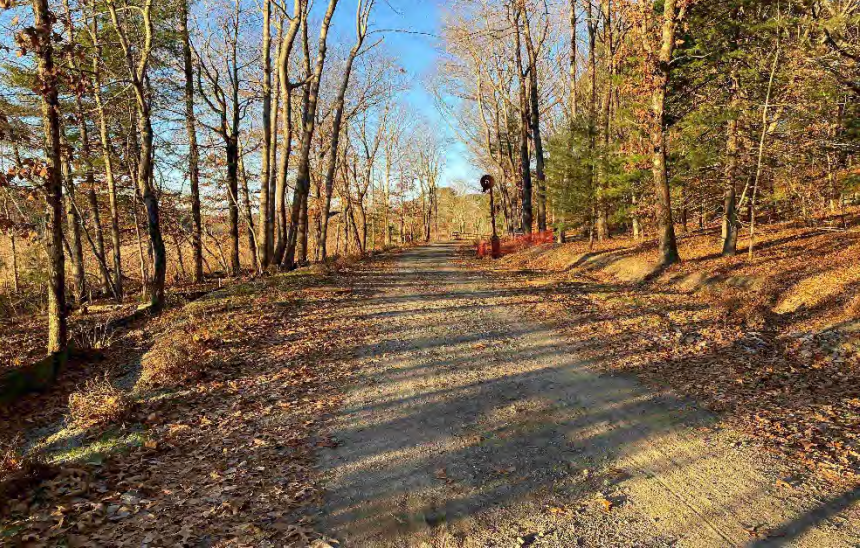
<p>PHOTOGRAPHIC LOG</p>	
<p>Client Name: Eversource</p>		<p>Site Location: Sudbury to Hudson Transmission Reliability Project</p>	<p>Town: Sudbury</p>
<p>Photo No.: 4</p>	<p>Date: 12-4-24</p>

<p>Description:</p> <p>Work area within segment 14, manhole #26, area recently planted & hydro seeded, existing erosion control, looking westward.</p>

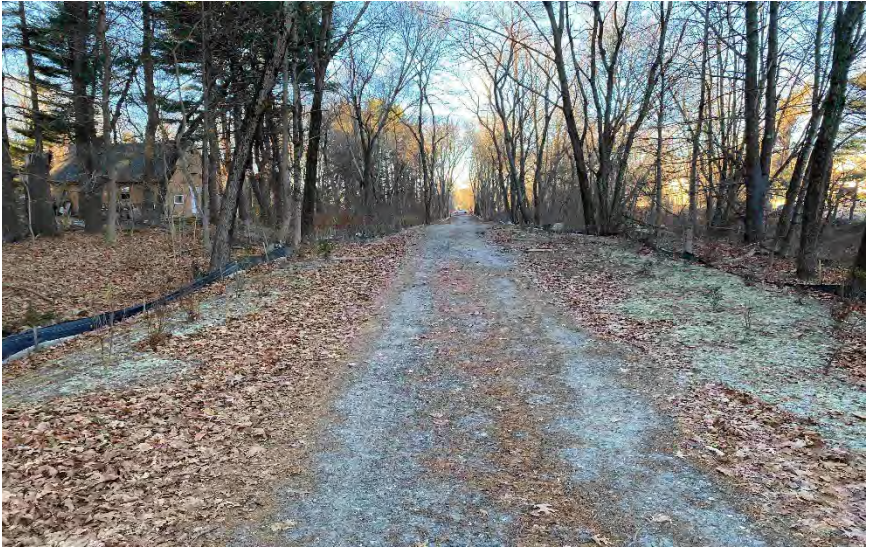
PHOTOGRAPHIC LOG	
Client Name: Eversource		Site Location: Sudbury to Hudson Transmission Reliability Project	Town: Sudbury
Photo No.: 5	Date: 12-4-24

Description: Work area within segment 13, manhole #25, area recently planted & hydro seeded, existing erosion control, looking westward.

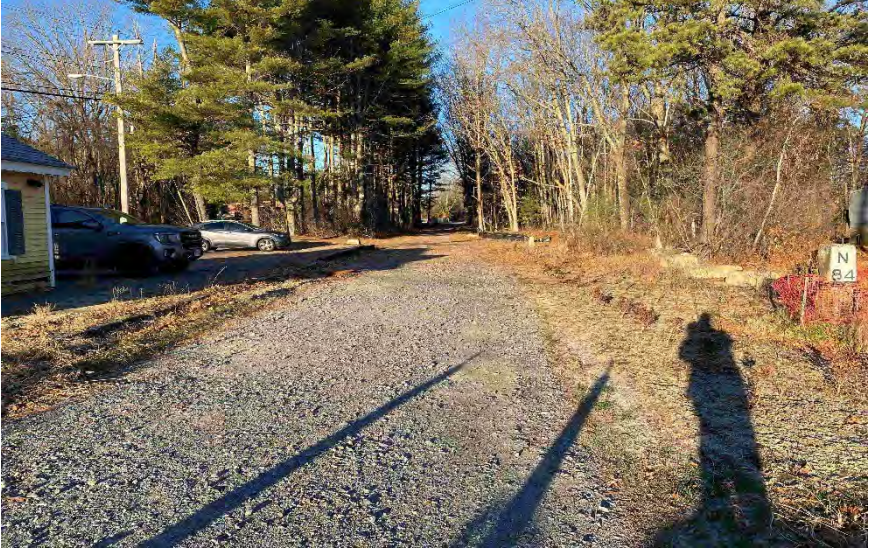
PHOTOGRAPHIC LOG	
Client Name: Eversource		Site Location: Sudbury to Hudson Transmission Reliability Project	Town: Sudbury
Photo No.: 6	Date: 12-4-24

Description: Work area within segment 11, manhole #24, erosion control recently removed from area, area recently planted & hydro seeded, existing erosion control, looking westward.

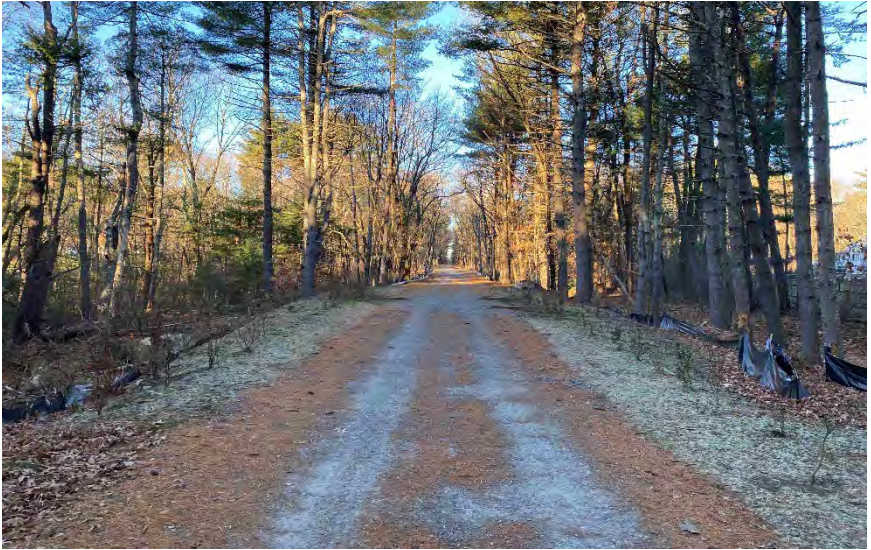
<p align="center">PHOTOGRAPHIC LOG</p>	
<p>Client Name: Eversource</p>		<p>Site Location: Sudbury to Hudson Transmission Reliability Project</p>	<p>Town: Sudbury</p>
<p>Photo No.: 7</p>	<p>Date: 12-4-24</p>

<p>Description:</p> <p>Work area within segment 9, manhole #19, area recently planted & hydro seeded, existing erosion control, looking westward.</p>

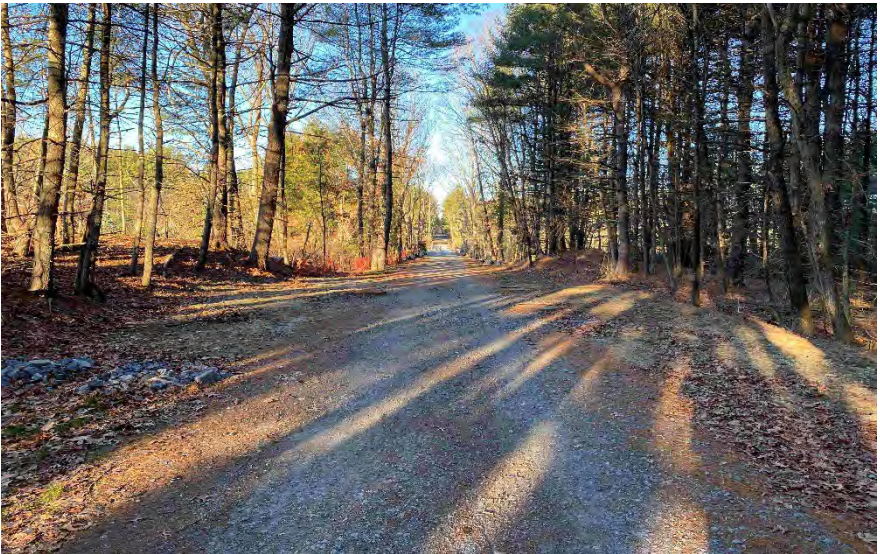
<p align="center">PHOTOGRAPHIC LOG</p>	
<p>Client Name: Eversource</p>		<p>Site Location: Sudbury to Hudson Transmission Reliability Project</p>	<p>Town: Sudbury</p>
<p>Photo No.: 8</p>	<p>Date: 12-4-24</p>

<p>Description:</p> <p>Work area within segment 8, manhole #17, area recently hydro seeded, existing erosion control, looking westward.</p>

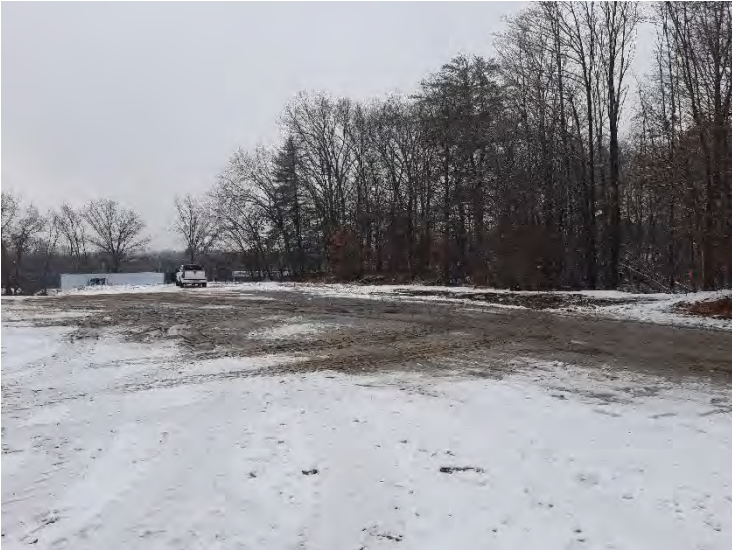
<p>PHOTOGRAPHIC LOG</p>	
<p>Client Name: Eversource</p>		<p>Site Location: Sudbury to Hudson Transmission Reliability Project</p>	<p>Town: Hudson</p>
<p>Photo No.: 1</p>	<p>Date: 12-5-24</p>

<p>Description:</p> <p>Behind 188 Central Street, remaining conduit bundles have been removed from upper lot, Bond continuing cleanup in lower area, looking southward.</p>

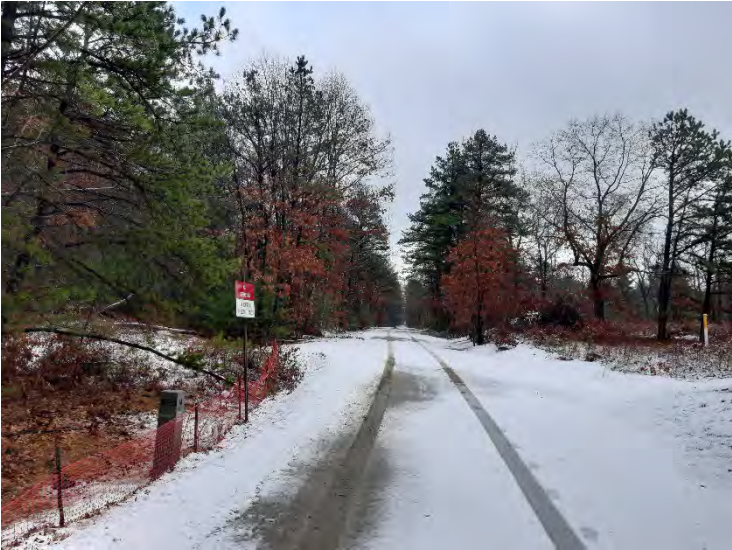
<p>PHOTOGRAPHIC LOG</p>	
<p>Client Name: Eversource</p>		<p>Site Location: Sudbury to Hudson Transmission Reliability Project</p>	<p>Town: Hudson/Sudbury</p>
<p>Photo No.: 5</p>	<p>Date: 12-5-24</p>

<p>Description:</p> <p>Town line, Segment 6 into Segment 7, limited project activity in this area outside of transiting ROW. Looking eastward.</p>

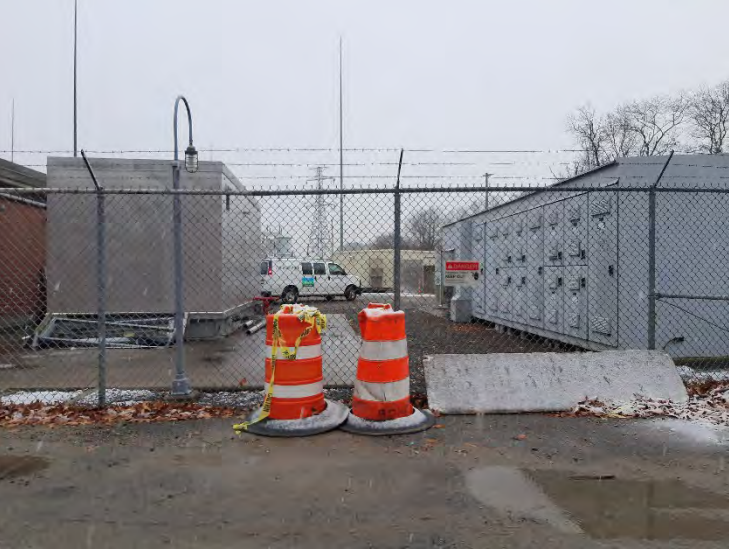
<p align="center">PHOTOGRAPHIC LOG</p>	
<p>Client Name: Eversource</p>		<p>Site Location: Sudbury to Hudson Transmission Reliability Project</p>	<p>Town: Sudbury</p>
<p>Photo No.: 8</p>	<p>Date: 12-5-24</p>

<p>Description:</p> <p>Sudbury substation, activity noted within substation, looking northward.</p>

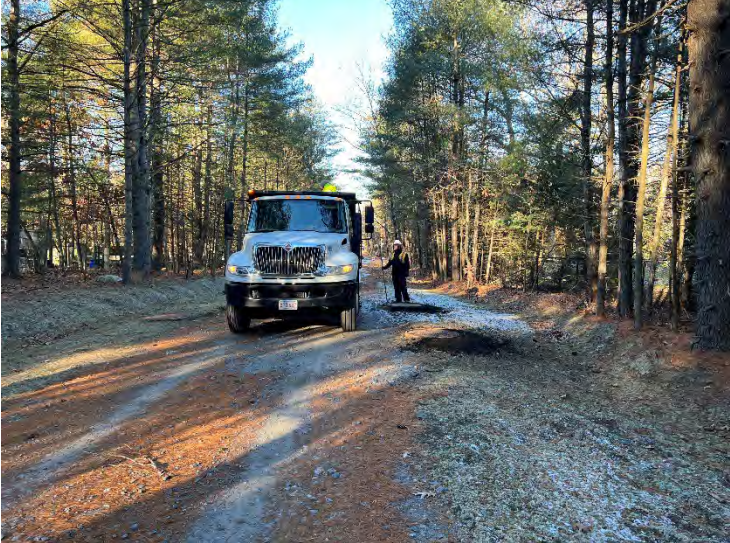
PHOTOGRAPHIC LOG	
Client Name: Eversource		Site Location: Sudbury to Hudson Transmission Reliability Project	Town: Sudbury
Photo No.: 1	Date: 12/6/2024

Description: View of ET&L applying soil and grading at MH#18 in segment 9. Facing west.

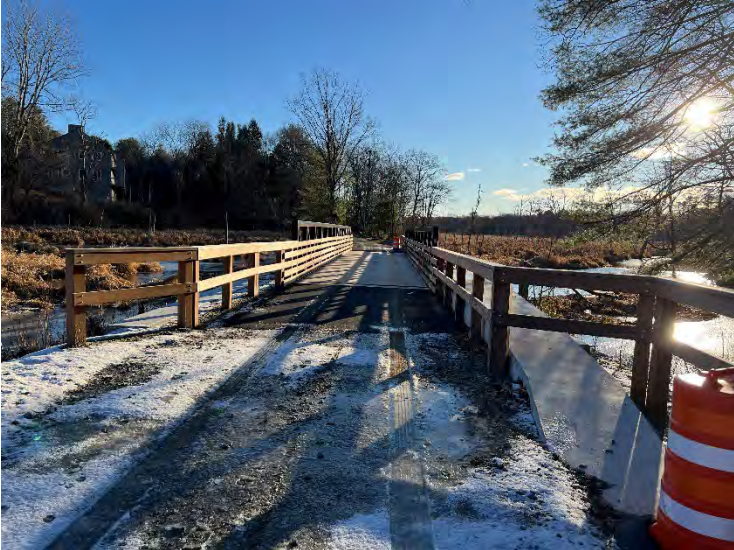
PHOTOGRAPHIC LOG	
Client Name: Eversource		Site Location: Sudbury to Hudson Transmission Reliability Project	Town: Sudbury
Photo No.: 2	Date: 12/6/2024

Description: View of Bridge 127. Facing east.

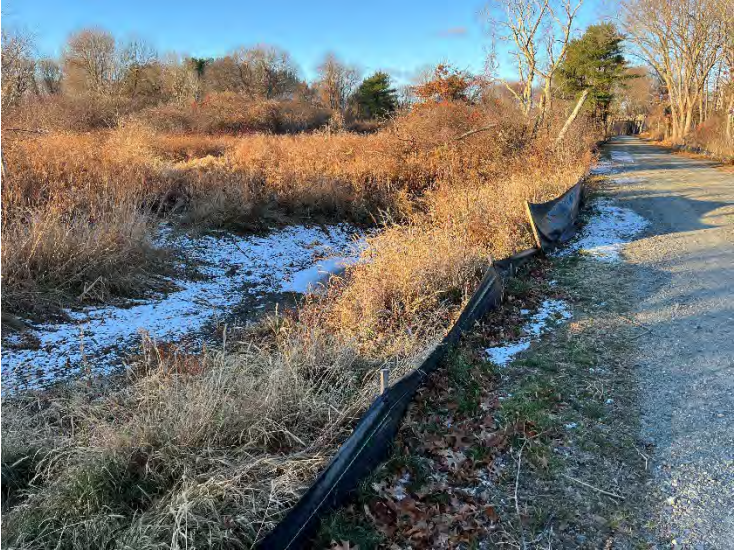
<p>PHOTOGRAPHIC LOG</p>	
<p>Client Name: Eversource</p>		<p>Site Location: Sudbury to Hudson Transmission Reliability Project</p>	<p>Town: Sudbury</p>
<p>Photo No.: 3</p>	<p>Date: 12/6/2024</p>

<p>Description: View of the wetland replication area in segment 14. Facing west.</p>

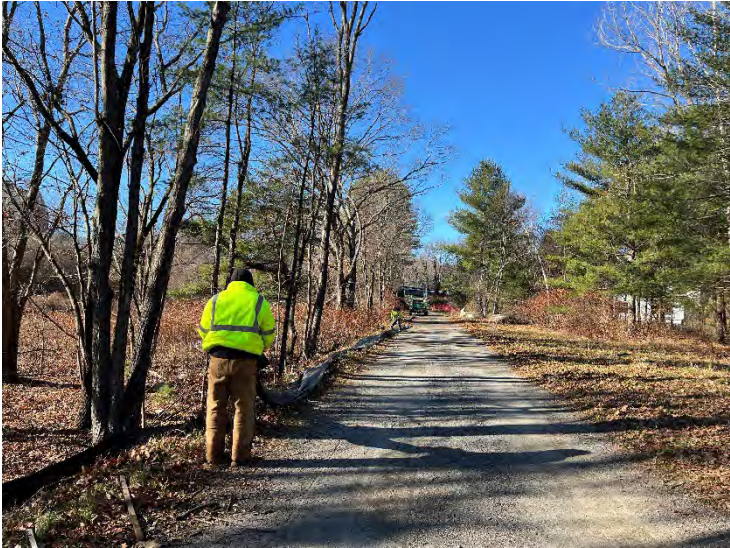
<p>PHOTOGRAPHIC LOG</p>	
<p>Client Name: Eversource</p>		<p>Site Location: Sudbury to Hudson Transmission Reliability Project</p>	<p>Town: Hudson</p>
<p>Photo No.: 5</p>	<p>Date: 12/6/2024</p>

<p>Description: View of MON removing approved erosion controls in segment 2. Facing west.</p>

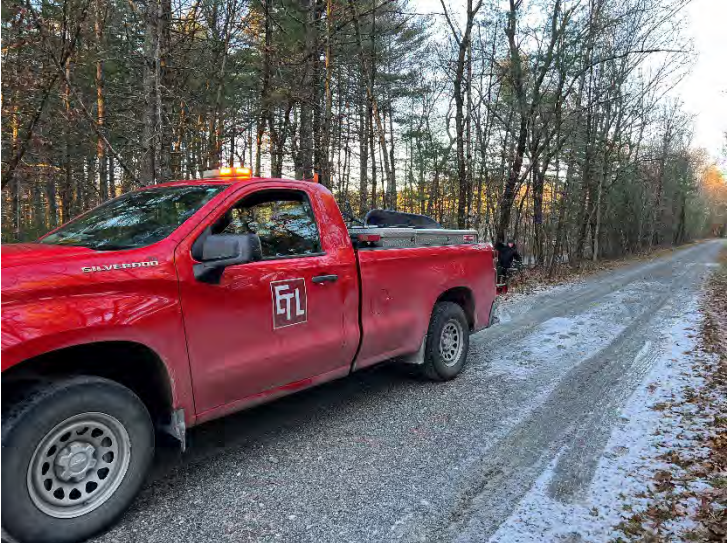
<p>PHOTOGRAPHIC LOG</p>	
<p>Client Name: Eversource</p>		<p>Site Location: Sudbury to Hudson Transmission Reliability Project</p>	<p>Town: Hudson</p>
<p>Photo No.: 6</p>	<p>Date: 12/6/2024</p>

<p>Description: View of ET&L removing stumps in segment 5. Facing southwest.</p>

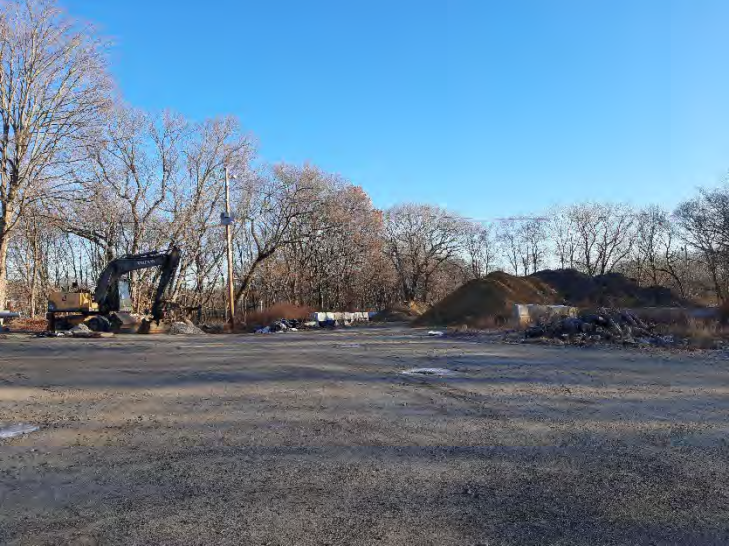
PHOTOGRAPHIC LOG	
Client Name: Eversource		Site Location: Sudbury to Hudson Transmission Reliability Project	Town: Hudson
Photo No.: 2	Date: 12-2-24

Description: Stowe Court laydown yard, ET&L excavator staged at yard, looking southward.

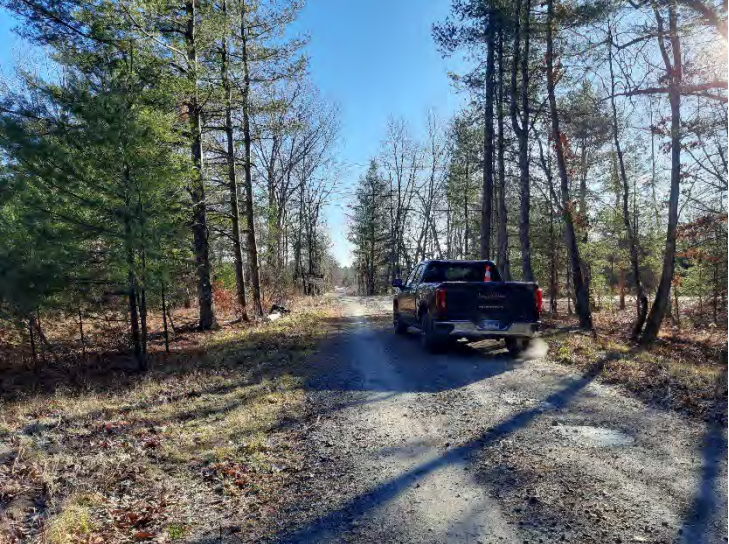
PHOTOGRAPHIC LOG	
Client Name: Eversource		Site Location: Sudbury to Hudson Transmission Reliability Project	Town: Hudson
Photo No.: 6	Date: 12-2-24

Description: Segment 2, Eversource observing ROW, looking eastward.

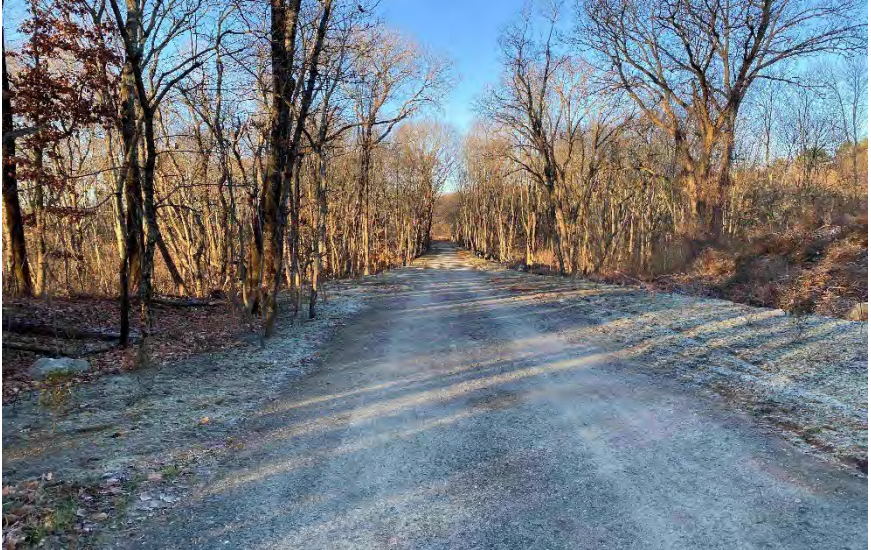
PHOTOGRAPHIC LOG	
Client Name: Eversource		Site Location: Sudbury to Hudson Transmission Reliability Project	Town: Sudbury
Photo No.: 1	Date: 12-2-24

Description: Work area within segment 14, manhole #27 area, recent plantings & hydroseeding, existing erosion control, looking westward.

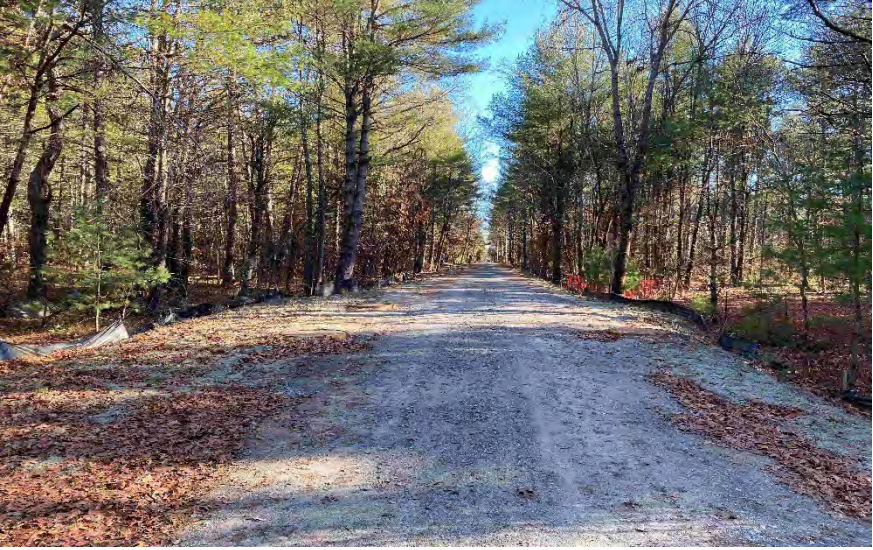
PHOTOGRAPHIC LOG	
Client Name: Eversource		Site Location: Sudbury to Hudson Transmission Reliability Project	Town: Sudbury
Photo No.: 5	Date: 12-2-24

Description: Work area within Segment 7, manhole #15, area recently hydroseeded, existing erosion control, looking eastward.

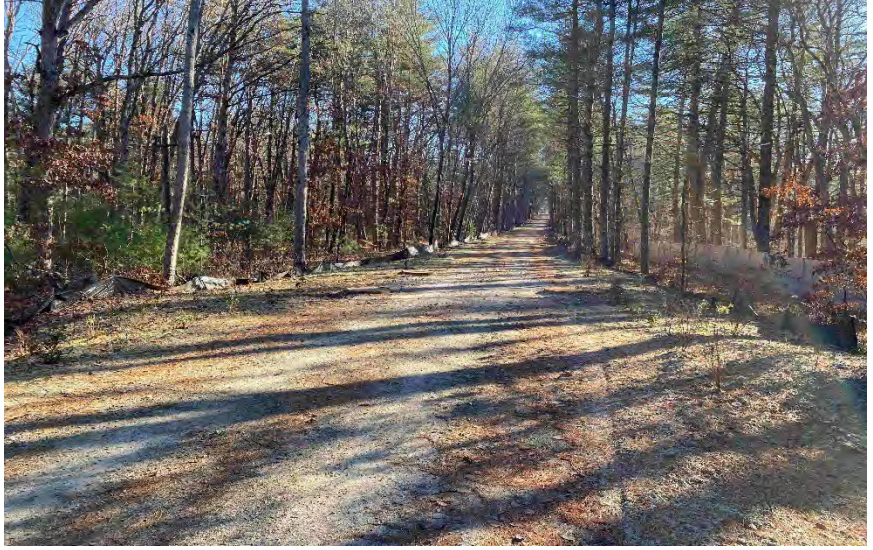
PHOTOGRAPHIC LOG	
Client Name: Eversource		Site Location: Sudbury to Hudson Transmission Reliability Project	Town: Sudbury
Photo No.: 6	Date: 12-2-24

Description: Work area within Segment 10, manhole #20, recent plantings & hydroseeding, existing erosion control, looking eastward.

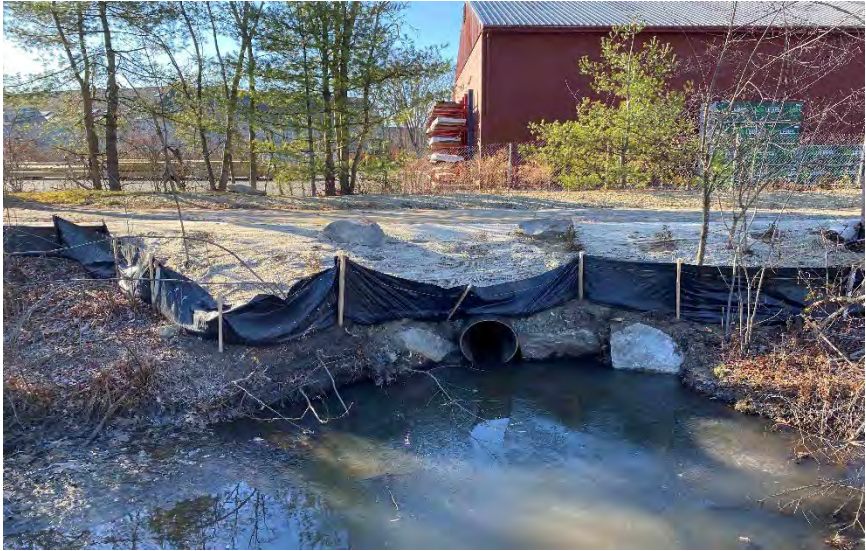
Epsilon ASSOCIATES INC.		PHOTOGRAPHIC LOG	
Client Name: Eversource		Site Location: Sudbury to Hudson Transmission Reliability Project	Town: Sudbury
Photo No.: 7	Date: 12-2-24

Description: Work area within segment 12, culvert extension area, existing erosion control, looking northward.

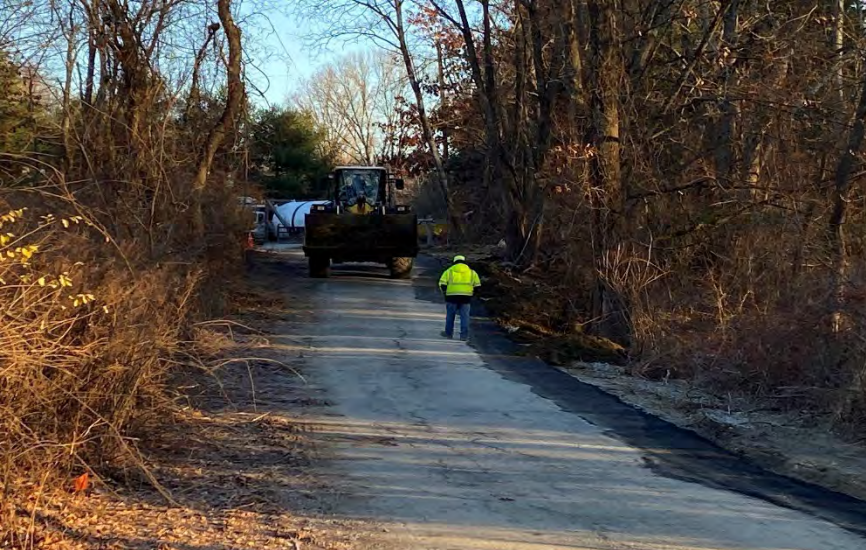
Epsilon ASSOCIATES INC.		PHOTOGRAPHIC LOG	
Client Name: Eversource		Site Location: Sudbury to Hudson Transmission Reliability Project	Town: Sudbury
Photo No.: 8	Date: 12-2-24

Description: Sudbury substation area, adjacent to Segment 14, work unrelated to project in progress. Looking northward.
