**Sudbury to Hudson TRP Week of 1/06/2025**

**Epsilon Team Full SWPPP Inspection Report(s)**

## Sudbury to Hudson Transmission Project

Weekly    Storm Event    Other   Date: **1-09-2025**   Time: **11:00am-12:30pm**

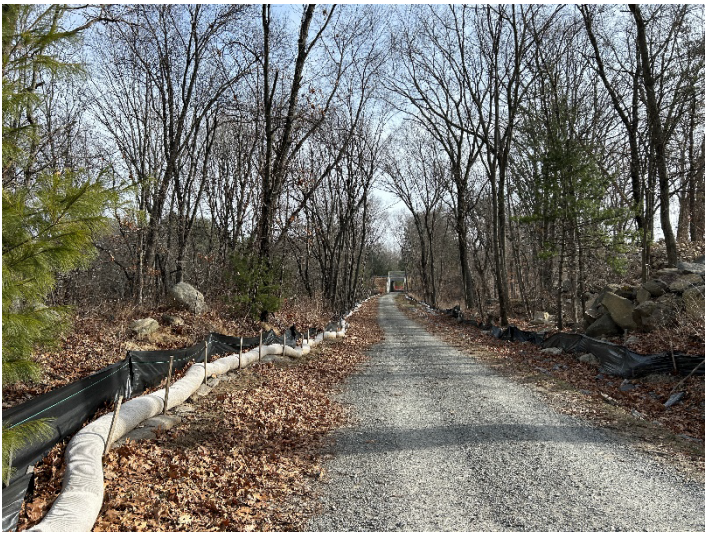
<b>PHOTOGRAPHIC LOG</b>	
<b>Client Name:</b> Eversource		<b>Site Location:</b> Sudbury to Hudson Transmission Reliability Project	<b>Town:</b> Hudson
<b>Photo No.:</b> 2	<b>Date:</b> 1-09-2025

<b>Description:</b> View of E&S controls in segment 1. Facing east.

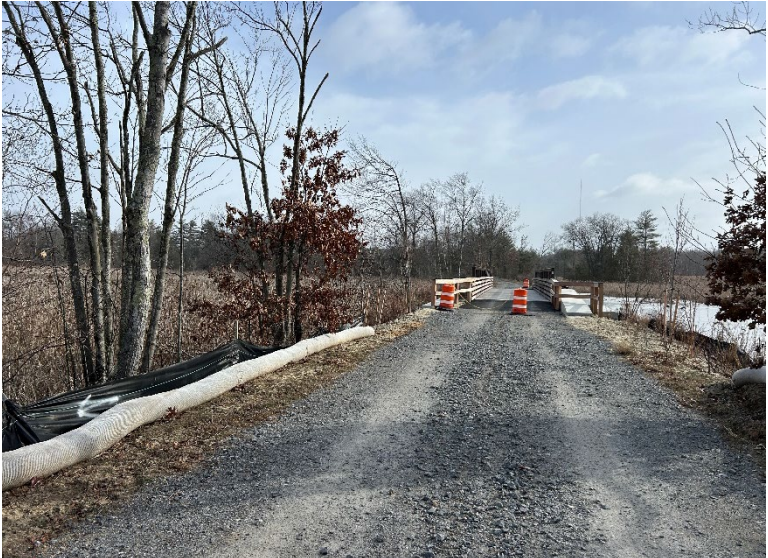
<b>PHOTOGRAPHIC LOG</b>	
<b>Client Name:</b> Eversource		<b>Site Location:</b> Sudbury to Hudson Transmission Reliability Project	<b>Town:</b> Hudson
<b>Photo No.:</b> 3	<b>Date:</b> 1-09-2025

<b>Description:</b> View of E&S controls and bridge 130 in segment 2. Facing east.

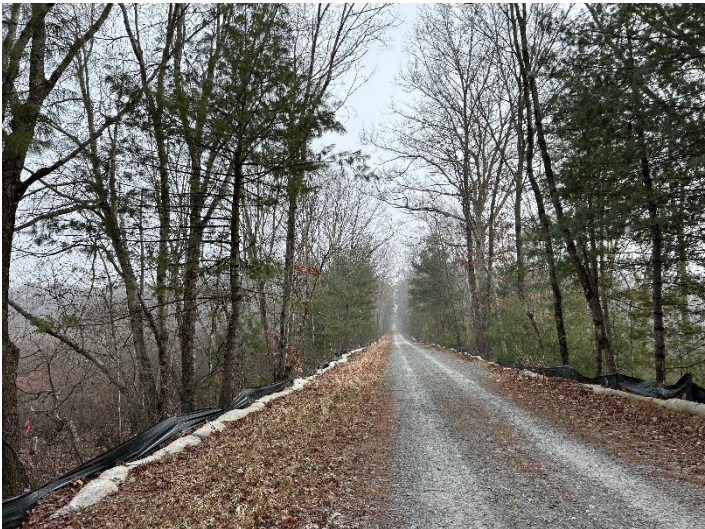
<b>Epsilon</b> ASSOCIATES INC.		<b>PHOTOGRAPHIC LOG</b>	
Client Name: Eversource		Site Location: Sudbury to Hudson Transmission Reliability Project	Town: Hudson
Photo No.: 6	Date: 1-09-2025

<b>Description:</b> View of E&S controls in segment 5. Facing east.

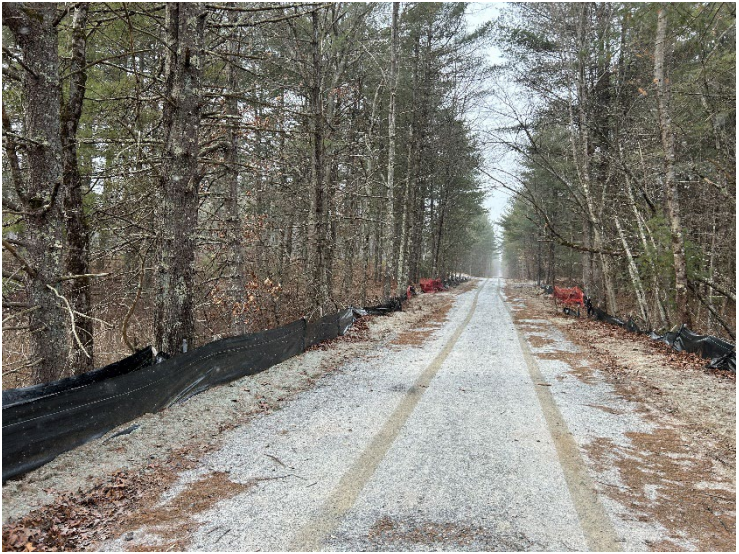
<b>Epsilon</b> ASSOCIATES INC.		<b>PHOTOGRAPHIC LOG</b>	
Client Name: Eversource		Site Location: Sudbury to Hudson Transmission Reliability Project	Town: Sudbury
Photo No.: 4	Date: 1-09-2025

<b>Description:</b>  View of E&S controls in segment 7. Facing west.

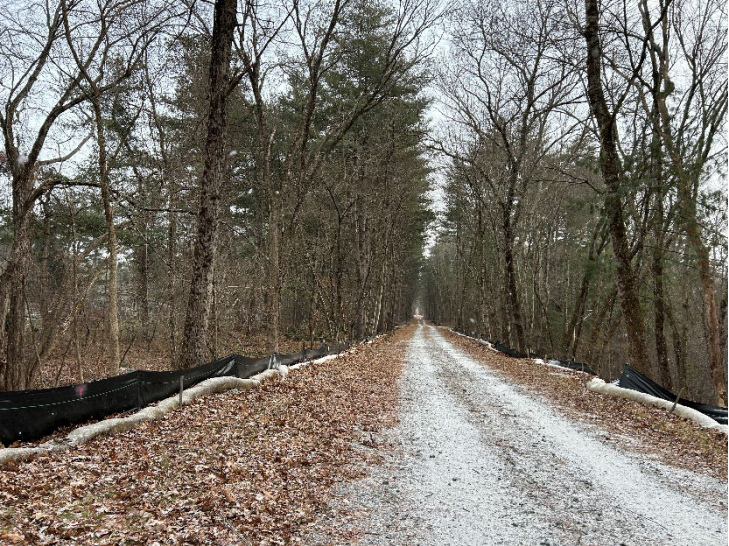
<b>Epsilon</b> ASSOCIATES INC.		<b>PHOTOGRAPHIC LOG</b>	
Client Name: Eversource		Site Location: Sudbury to Hudson Transmission Reliability Project	Town: Sudbury
Photo No.: 5	Date: 1-09-2025

<b>Description:</b>  View of E&S controls in segment 9. Facing east.

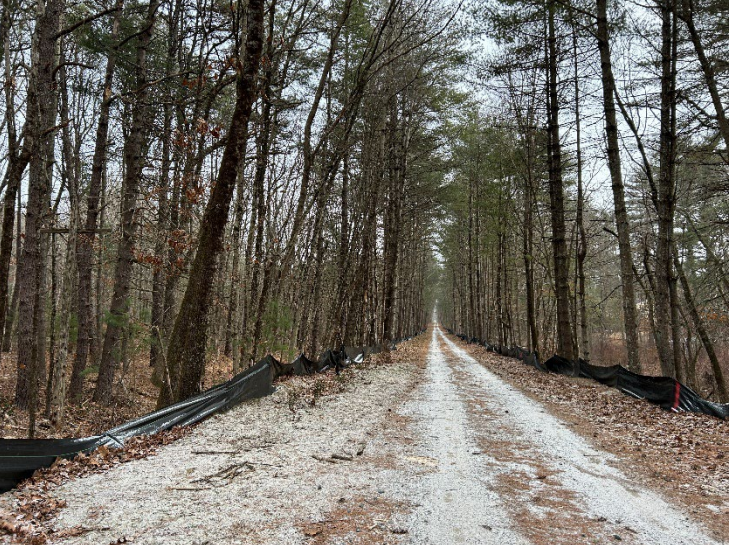
<b>Epsilon</b> ASSOCIATES INC.		<b>PHOTOGRAPHIC LOG</b>	
Client Name: Eversource		Site Location: Sudbury to Hudson Transmission Reliability Project	Town: Sudbury
Photo No.: 6	Date: 1-09-2025

<b>Description:</b>  View of E&S controls in segment 10. Facing east.

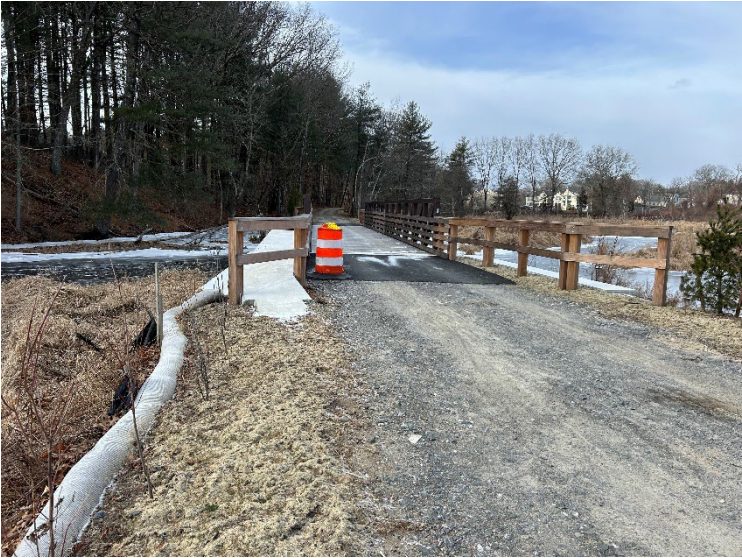
<b>Epsilon</b> ASSOCIATES INC.		<b>PHOTOGRAPHIC LOG</b>	
Client Name: Eversource		Site Location: Sudbury to Hudson Transmission Reliability Project	Town: Sudbury
Photo No.: 7	Date: 1-09-2025

<b>Description:</b>  View of bridge 127 and E&S controls from segment 14. Facing west.

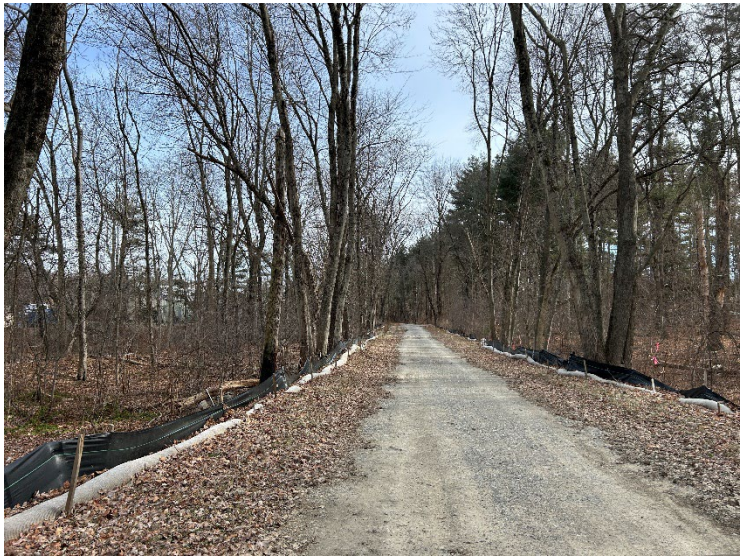
<b>Epsilon</b> ASSOCIATES INC.		<b>PHOTOGRAPHIC LOG</b>	
Client Name: Eversource		Site Location: Sudbury to Hudson Transmission Reliability Project	Town: Sudbury
Photo No.: 8	Date: 1-09-2025

<b>Description:</b>  View of E&S controls in segment 13. Facing east.
