Environmental Monitor Construction Site Inspection Report
MassDOT Project #608164 Construction Contract # 119678
EM Report #46

Project Description: Bruce Freeman Rail Trail Right-of-Way
 Permit Description(s): Order of Conditions (MGL Chapter 131, Section 40 and 310 CMR 10.00, Mass DEP File No. 301-1362); 2022 EPA NPDES General Permit for Discharges from Construction Areas; U.S. Army Corps of Engineers Permit No NAE-2021-01975.

Project Name:	Bruce Freeman Rail Trail - Phase 2d - Sudbury
Date of Inspections:	1/30/2025
Bi Weekly/ Monthly Period Covered:	January Weekly Inspection #5
Inspector's Name(s):	Anna Haznar
Inspectors' Contact Information:	ahaznar@beta-inc.com

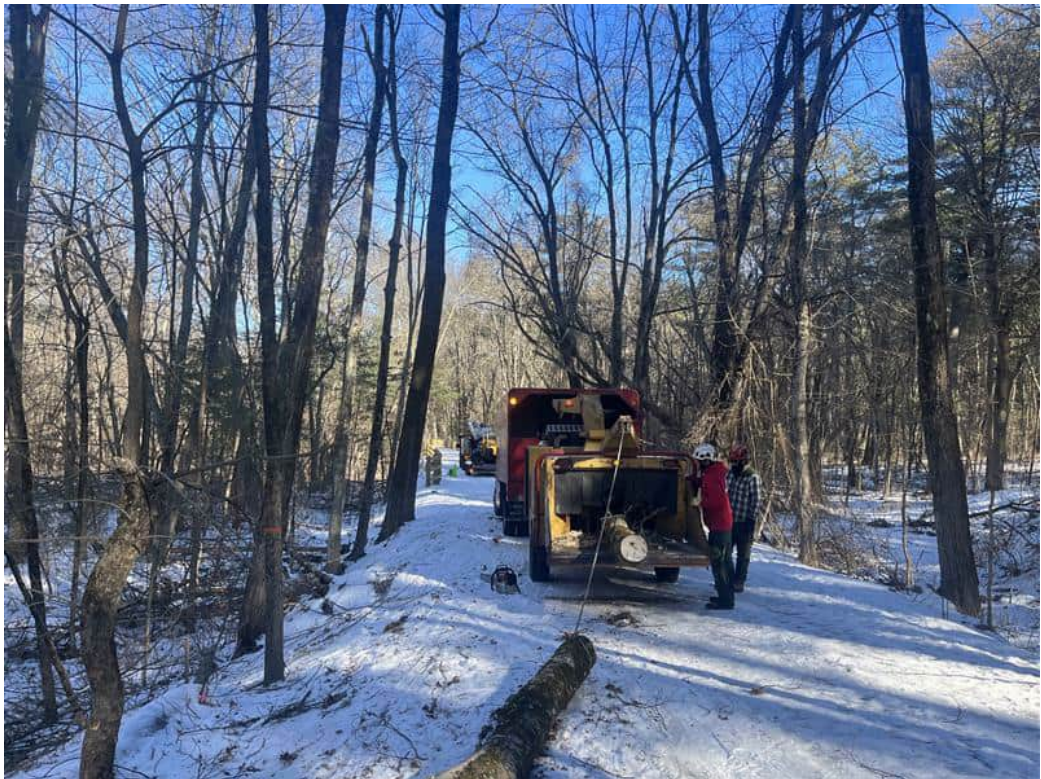
Site Location Bruce Freeman Rail Trail Right-of-Way		BETA Project No. 24.10326.23
Photo No. 9	Date: 1/30/2025	 
Direction Photo Taken: Toward the West		
Description: View of placed loam that requires stabilization at Station 311+00 per Long Term Compliance Action Item 59.		
Photo No. 10	Date: 1/30/2025	 
Direction Photo Taken: Toward the Southwest		
Description: View of a tree that has been removed and chipped at Station 323+50.
