Environmental Monitor Construction Site Inspection Report MassDOT Project #608164 Construction Contract # 119678 EM Report #59						
Project Description: Bruce Freeman Rail Trail Right-of-Way Permit Description(s): Order of Conditions (MGL Chapter 131, Section 40 and 310 CMR 10.00, Mass DEP File No. 301-1362); 2022 EPA NPDES General Permit for Discharges from Construction Areas; U.S. Army Corps of Engineers Permit No NAE-2021-01975.

I. General Project Information						
Project Name:	Bruce Freeman Rail Trail - Phase 2d - Sudbury					
Date of Inspections:	6/6/2025					
Bi Weekly/ Monthly Period Covered:	June Weekly Inspection #1					
Inspector's Name(s):	Anna Haznar					
Inspectors' Contact Information:	ahaznar@beta-inc.com					
II. Weather Information						
	Inspection #1	Inspection #2	Inspection #3	Inspection #4	Inspection #5	Inspection #6
WeatherUnderground	Inspector: Anna Haznar 6/6/2025	Inspector:	Inspector:	Inspector:	Inspector:	Inspector:
Type of Inspection (i.e. non-storm event, pre-storm event, during-storm event or post-storm event):	Non-storm					
Number of days since last rain event greater than .25"						
Has there been a storm event since the last inspection?	No					
I

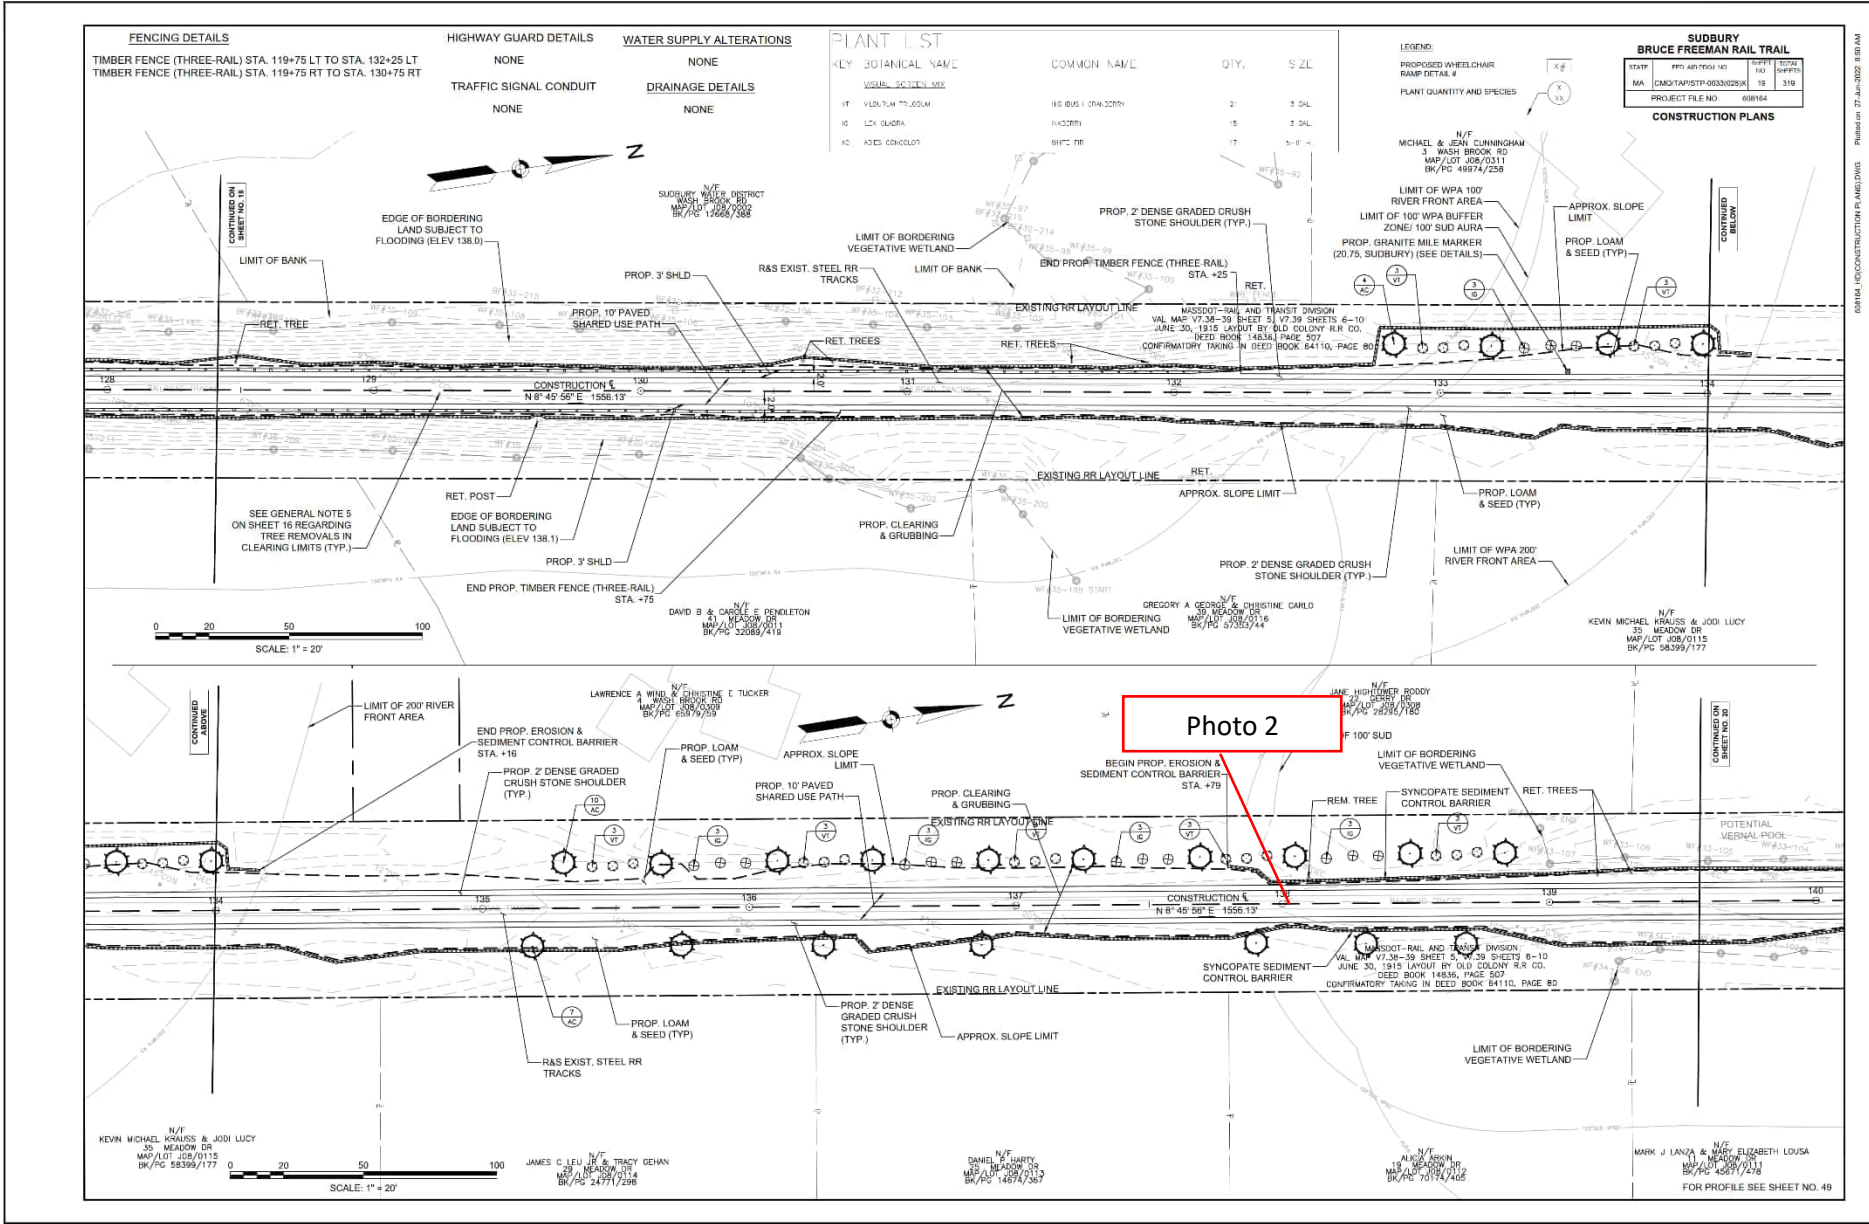
Site Location		Bruce Freeman Rail Trail Right-of-Way	BETA Project No. 24.10326.23
Photo No. 1	Date: 6/6/2025	 	
Direction Photo Taken: Toward the North			
Description: View of the location of the overtopped compost filter tube and exposed soils beyond the limits of work at Station 105+00 per Compliance Action Item 43.			
Photo No. 2	Date: 6/6/2025	 	
Direction Photo Taken: Toward the South			
Description: View of exposed soil that requires stabilization at Station 138+00 per Long Term Compliance Action item 59.

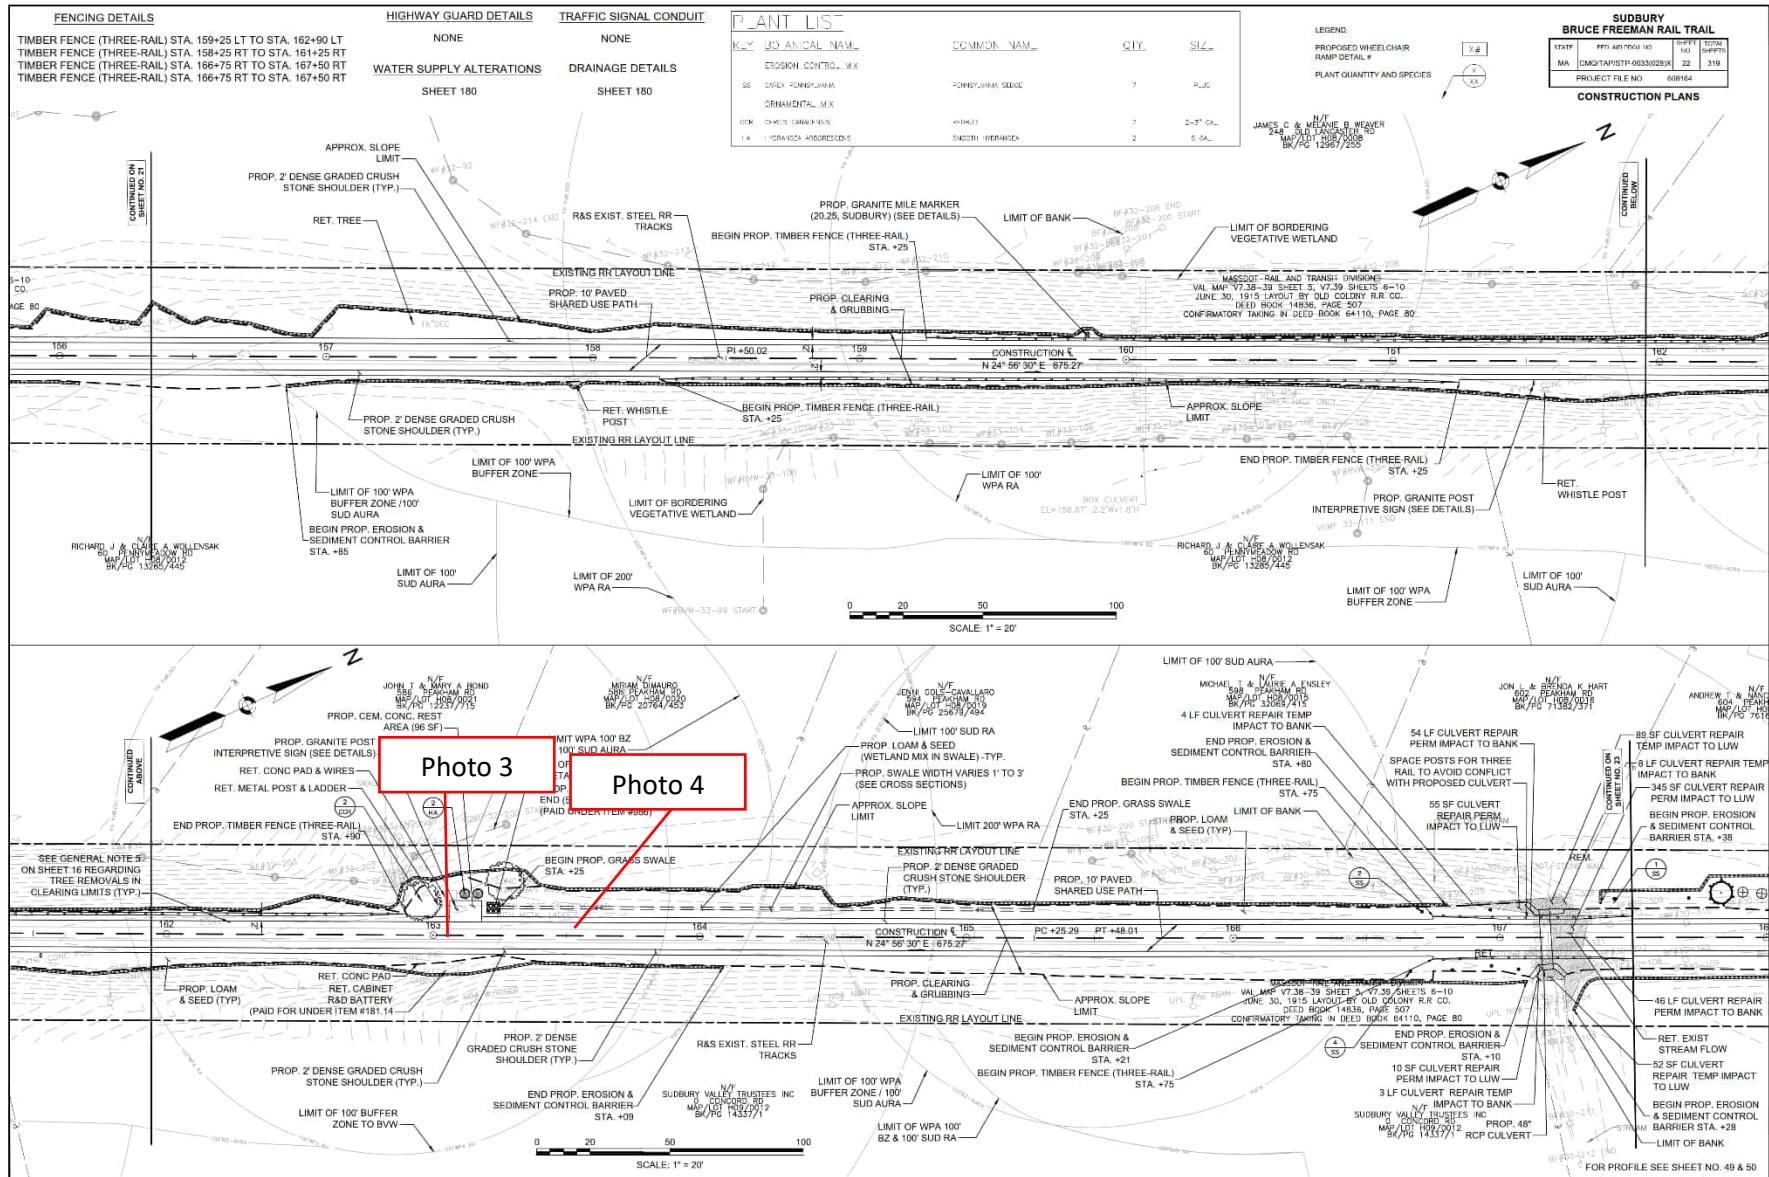
Site Location		Bruce Freeman Rail Trail Right-of-Way	BETA Project No. 24.10326.23
Photo No. 3	Date: 6/6/2025	 	
Direction Photo Taken: Toward the North			
Description: View of exposed soil that requires stabilization at Station 163+00 per Long Term Compliance Action item 59.			
Photo No. 4	Date: 6/6/2025	 	
Direction Photo Taken: Toward the South			
Description: View of Japanese hops that require removal in an area of exposed soil at Station 163+50 per Long Term Compliance Action Item 59 and 61.

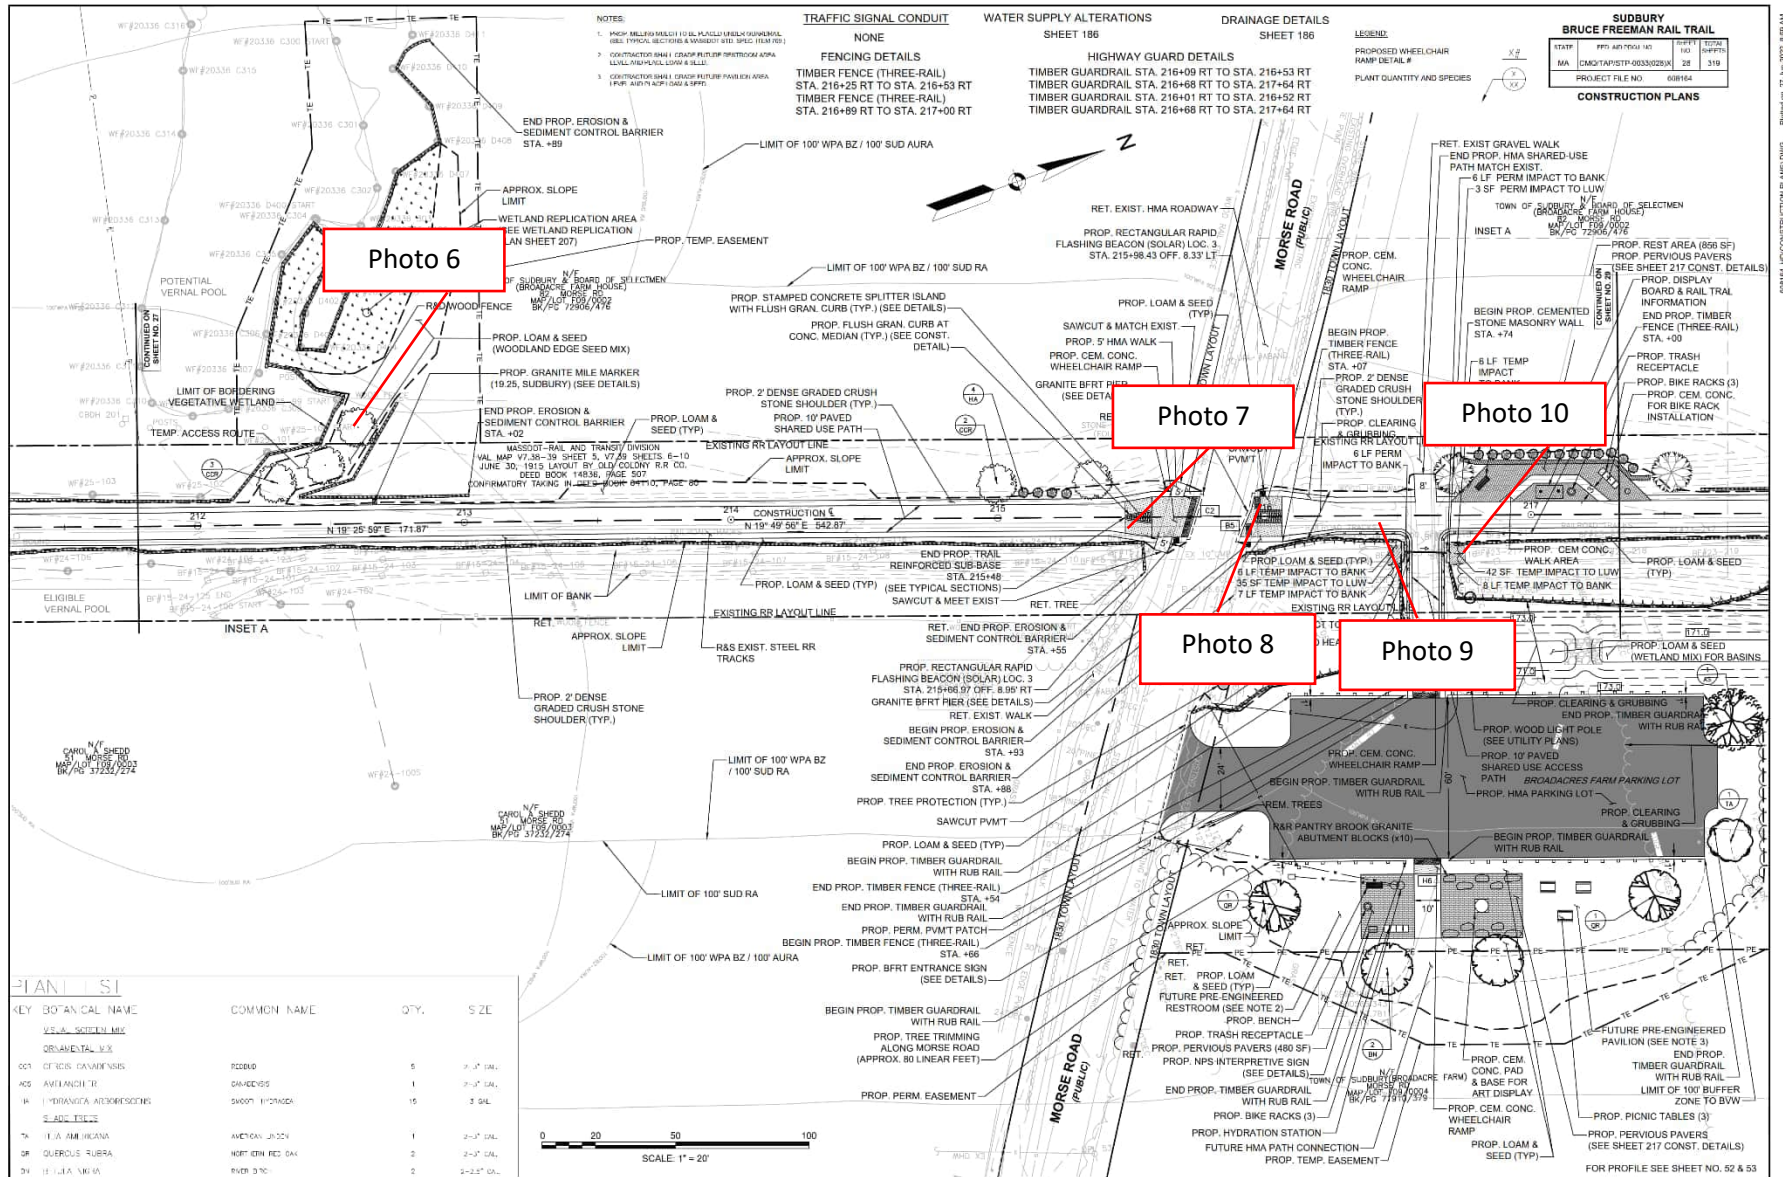
Site Location		Bruce Freeman Rail Trail Right-of-Way	BETA Project No. 24.10326.23
Photo No. 7	Date: 6/6/2025	 	
Direction Photo Taken: Toward the South			
Description: View of the location where the stream bank has been regraded beyond the limits of work and exposed soils along the Bank at Station 215+75 per Long Term Compliance Action Items 41 and 62. Note some vegetation has been observed along the Bank.			
Photo No. 8	Date: 6/6/2025	 	
Direction Photo Taken: Toward the East			
Description: View of plantings being installed at Station 216+00.
