Environmental Monitor Construction Site Inspection Report MassDOT Project #608164 Construction Contract # 119678 EM Report #60						
Project Description: Bruce Freeman Rail Trail Right-of-Way Permit Description(s): Order of Conditions (MGL Chapter 131, Section 40 and 310 CMR 10.00, Mass DEP File No. 301-1362); 2022 EPA NPDES General Permit for Discharges from Construction Areas; U.S. Army Corps of Engineers Permit No NAE-2021-01975.

I. General Project Information						
Project Name:	Bruce Freeman Rail Trail - Phase 2d - Sudbury					
Date of Inspections:	6/9/2025					
Bi Weekly/ Monthly Period Covered:	June Weekly Inspection #2					
Inspector's Name(s):	Anna Haznar					
Inspectors' Contact Information:	ahaznar@beta-inc.com					
II. Weather Information						
	Inspection #1	Inspection #2	Inspection #3	Inspection #4	Inspection #5	Inspection #6
Weather Underground	Inspector: Anna Haznar 6/6/2025	Inspector: Anna Haznar 6/9/2025	Inspector:	Inspector:	Inspector:	Inspector:
Type of Inspection (i.e. non-storm event, pre-storm event, during-storm event or post-storm event):	Non-storm	Post-storm				
Number of days since last rain event greater than .25"		2				
Has there been a storm event sin

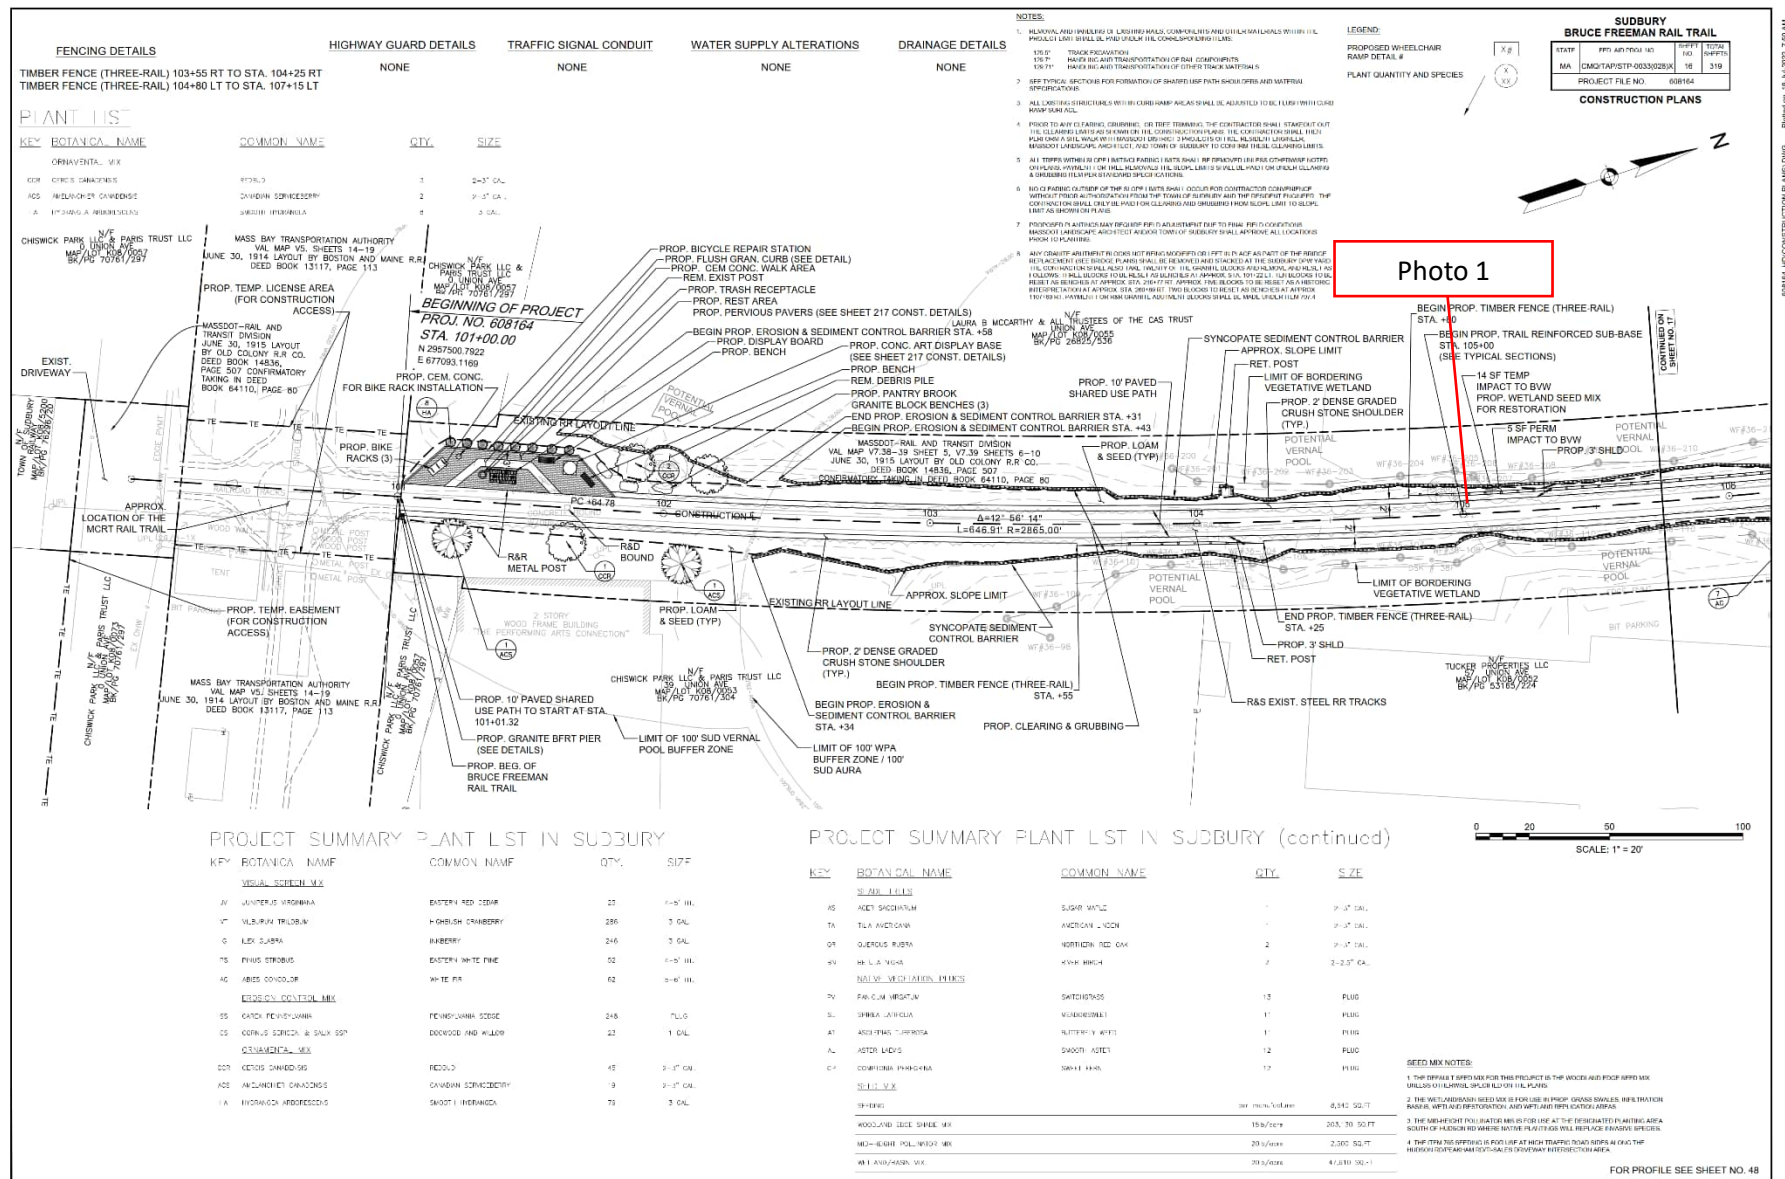
Site Location		Bruce Freeman Rail Trail Right-of-Way	BETA Project No. 24.10326.23
Photo No. 1	Date: 6/9/2025	 	
Direction Photo Taken: Toward the North			
Description: View of the location of the overtopped compost filter tube and exposed soils beyond the limits of work at Station 105+00 per Compliance Action Item 43.			
Photo No. 2	Date: 6/9/2025	 	
Direction Photo Taken: Toward the North			
Description: View of exposed soil that requires stabilization and bittersweet and barberry that require removal at Station 163+00 per Long Term Compliance Action item 59 and 61.
