# Featherland Park

## Town of Sudbury ADA Transition Plan

December 2020

Institute for Human Centered Design

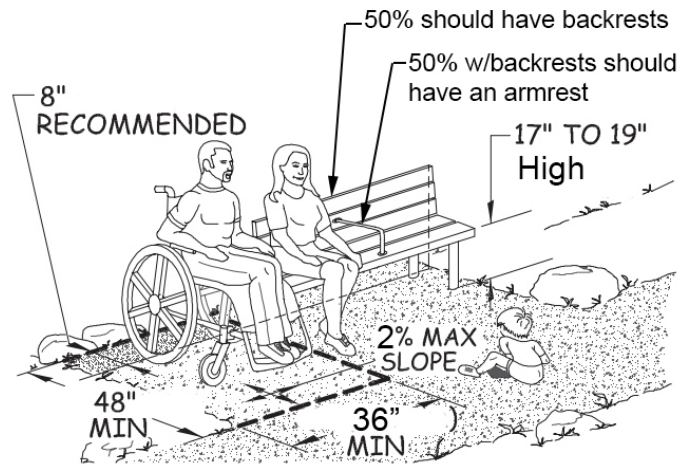
Accessibility issues include lack of accessible routes to the softball and baseball fields, including routes to team seating areas, practice areas and spectator seating areas. Additionally, wheelchair accessible spaces are not provided alongside team seating benches and bleachers.

- Recommend providing clear floor space of 36" wide minimum by 48" deep alongside one bench so that a wheelchair user can sit alongside someone sitting on the bench. See the following diagram:

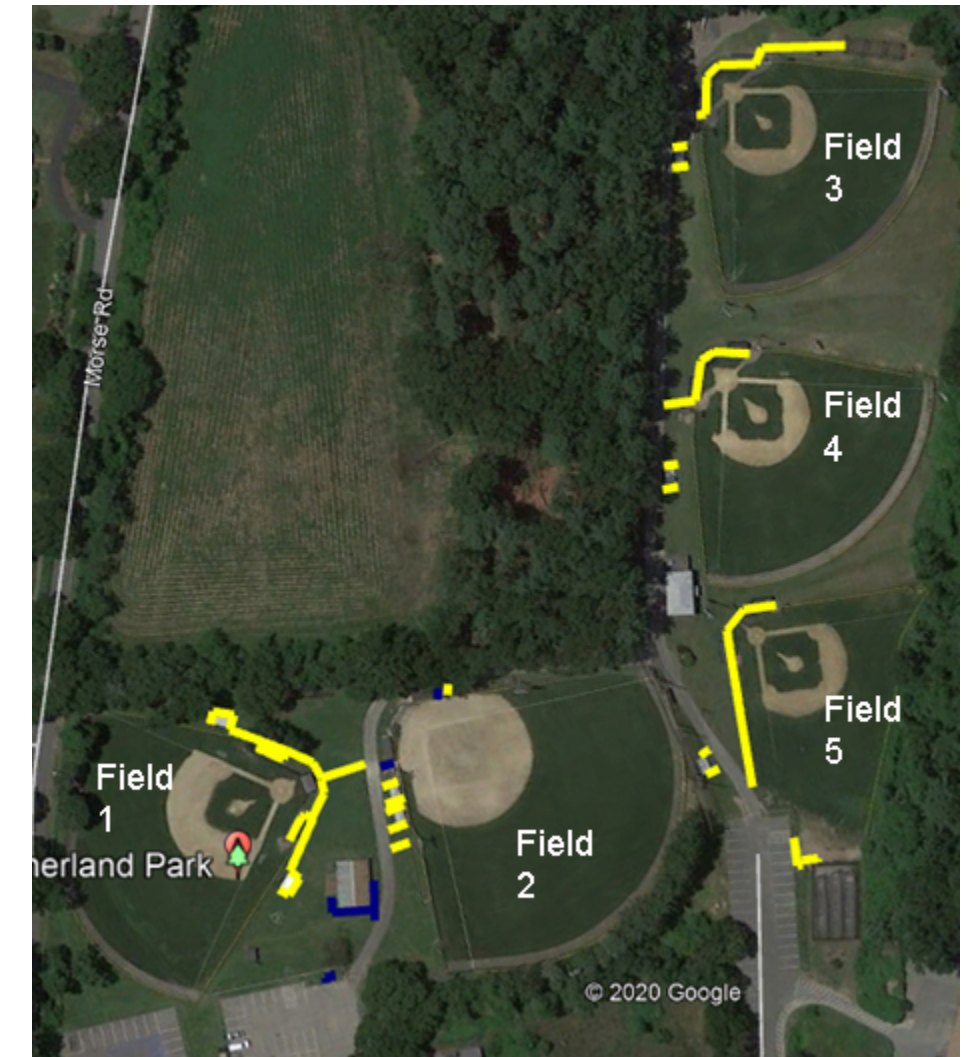
Accessibility issues include the lack of an accessible route to the south concession stand, waysides and trash bins. Additionally, some existing exterior routes have excess changes in level and are not maintained in operable working condition.

**Note:** The following image uses lines to show the approximate suggested location of accessible routes that need to be provided to amenities in Featherland Park. Yellow lines represent stone dust walkways and blue lines represent asphalt walkways.
