Feeley Field

Town of Sudbury ADA Transition Plan

December 2020

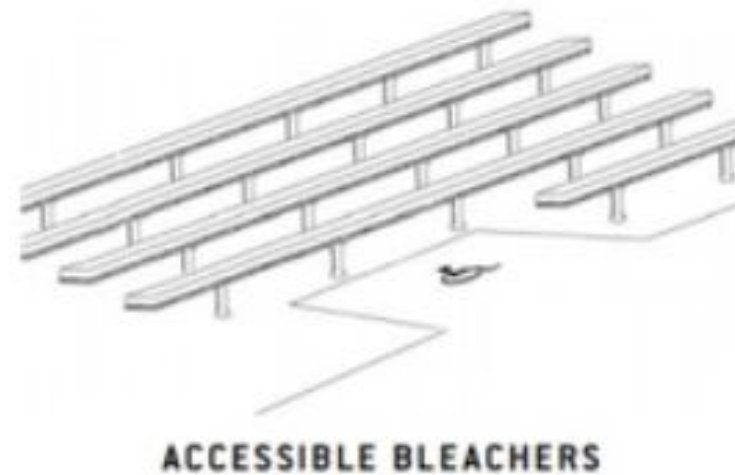
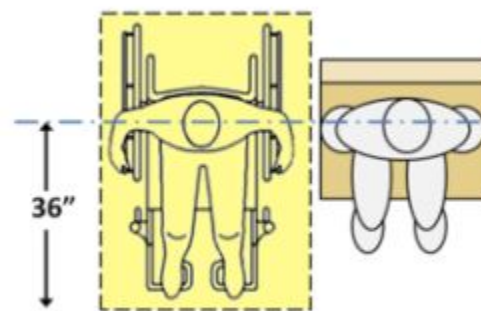
- Wheelchair accessible spaces are not provided alongside exterior benches, bleachers or team seating areas.
- Lack of compliant designation, information and directional signs.
- Three service counters are located higher than allowed and the two service counters in the north concession stand are not located on an accessible route.
- Lack of an accessible picnic table with toe and knee clearance by the north concession stand.
- Lack of an accessible route to one bench by the north softball field and to the trash container and wayside sign by the tennis courts. .

Note: The following graphics illustrate placement of accessible spaces alongside bleachers. Space for wheelchair users should be positioned so that a wheelchair user can sit shoulder to shoulder next to a person seated in the bleachers.

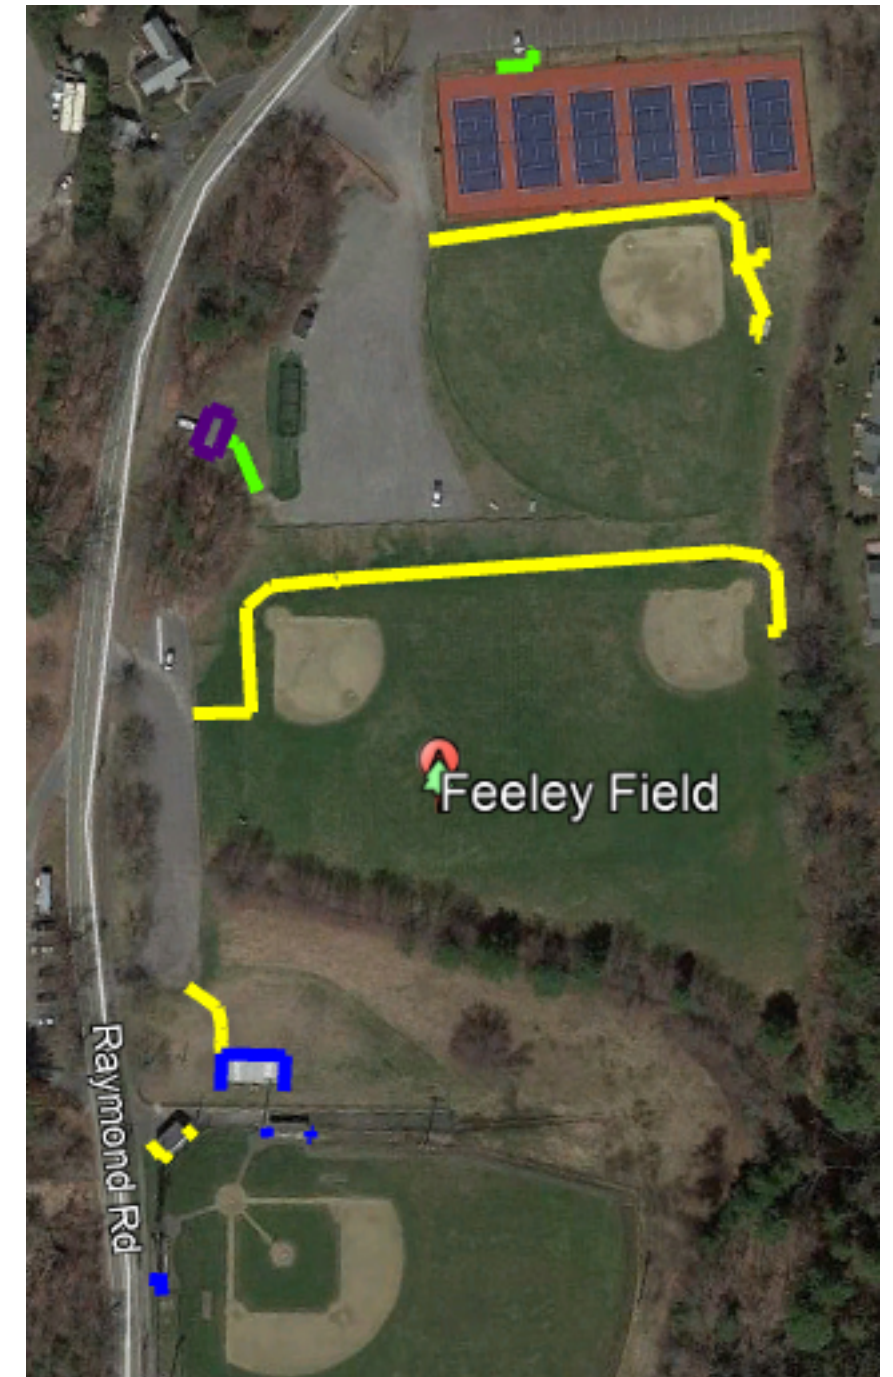
Accessibility issues include the lack of an accessible route between the parking lot and the tennis courts, lack of an accessible route between the tennis court and north softball field, and lack of an accessible route between the southwest and southeast softball fields and parking lot. There is also lack of accessible routes to team seating areas, spectator seating areas and practice areas, and an accessible route is not provided to the north concession stand and toilet rooms.

Note: The following image uses lines to show the approximate suggested location of accessible routes that need to be provided to amenities in Feeley Field. Yellow lines represent stone dust walkways, blue lines represent asphalt walkways, green lines represent concrete ramps and purple lines represent concrete walkways.
