FIELD NOTES SUMMARY

Customer: Hop Brook Protection Association

Site Location: Sudbury, MA

Date: 7/7/22, 8:00 AM

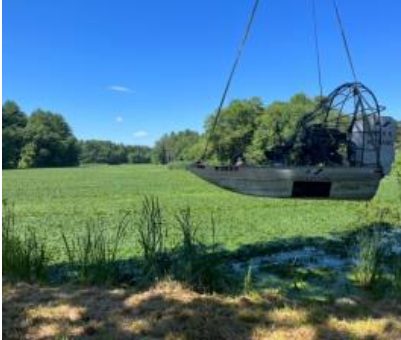
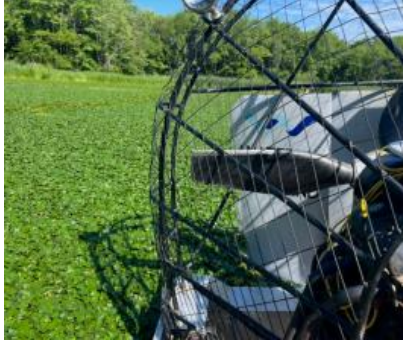
Upon arrival, a brief interim survey of each pond was conducted using visual observation. The ponds were all surveyed in advance of treatment and conditions were similar to those of the pre-treatment surveys (see pre-treatment survey data sent previously). It was however noted that the invasive curly leaf pondweed, a colder water invasive species, is dying off naturally, as expected due to the high water temperatures. Photos 1 and 2 display the conditions at Grist Millpond, photos 3 and 4 display Carding Millpond, and the last two photos show Stearns Millpond.

As planned, a treatment was conducted for the control of invasive water chestnut. Clearcast (imazamox), the approved herbicide under the Order of Conditions issued by Sudbury Conservation Commission, and the MA-DEP WM04 permit, was paired with a non-ionic surfactant. The mixture was applied to all water chestnut within the three ponds via foliar application using low-volume calibrated spray equipment. This methodology, which is approved under the Order of Conditions, allows for even coverage and distribution to the target water chestnut, while limiting any non-target impacts. Weather
