Weekly Environmental Compliance Summary

Sudbury to Hudson Transmission Reliability Project (USEPA Tracking # MAR1003UW)

Sudbury, Hudson, and Stow, MA

Week of: August 12, 2024 to August 17, 2024

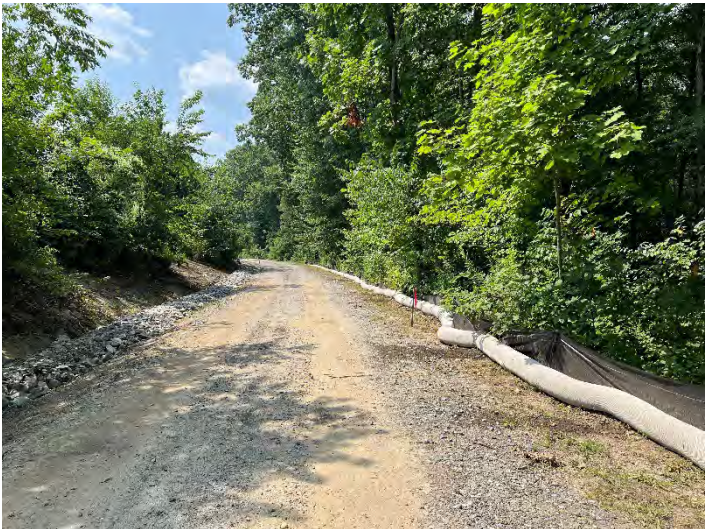
Description: View of E&S controls in segment 1. Facing west.

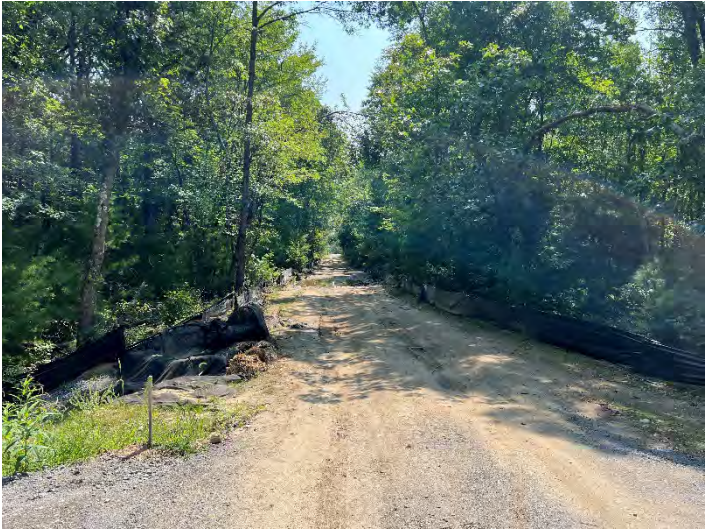
Description: View of E&S controls in segment 6 by MH#15. Facing east.

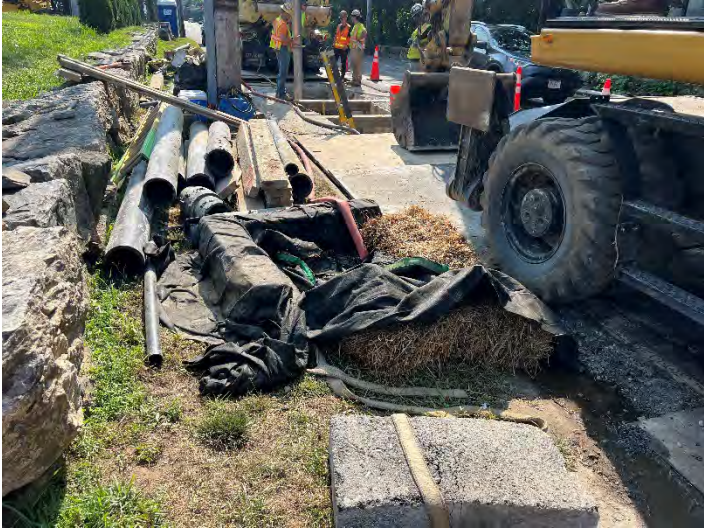
Description: View of dewatering controls (straw bale corral with filter fabric and silt bag). Facing east.

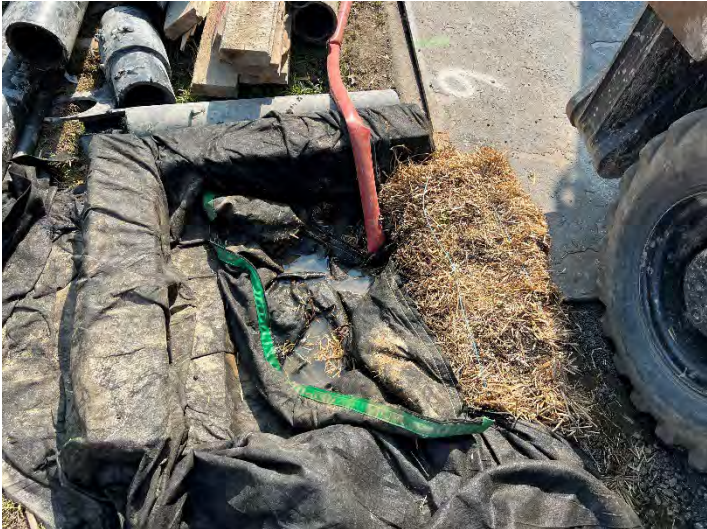
Description: View of discharging water within corral. Discharge appeared turbid and turbidity reading was above 50 NTUs. Water was being discharged to catch basin underneath filter fabric.

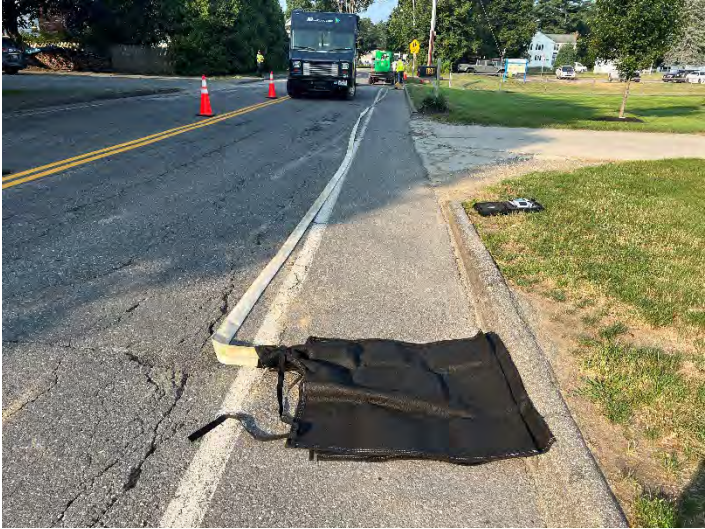
Description: View of dewatering controls (filter fabric with silt bag). Facing southwest.

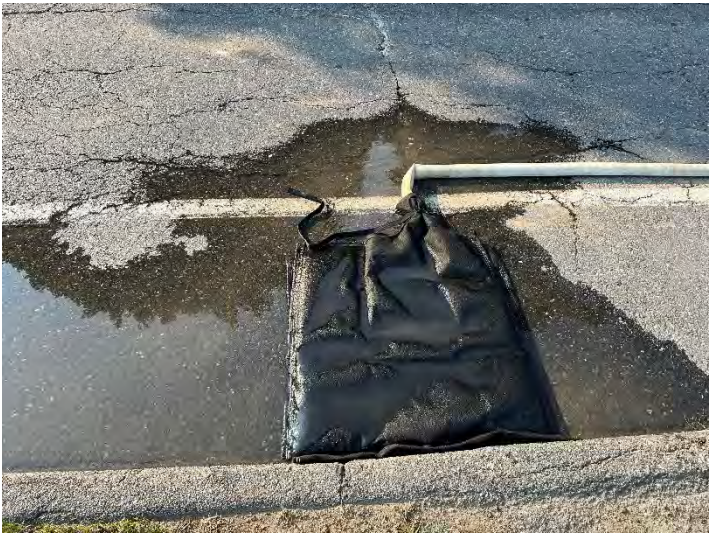
Description: View of discharging water from silt bag. Discharge appeared to be clear and turbidity reading was below 50 NTUs. Discharge to catch basin under filter fabric.

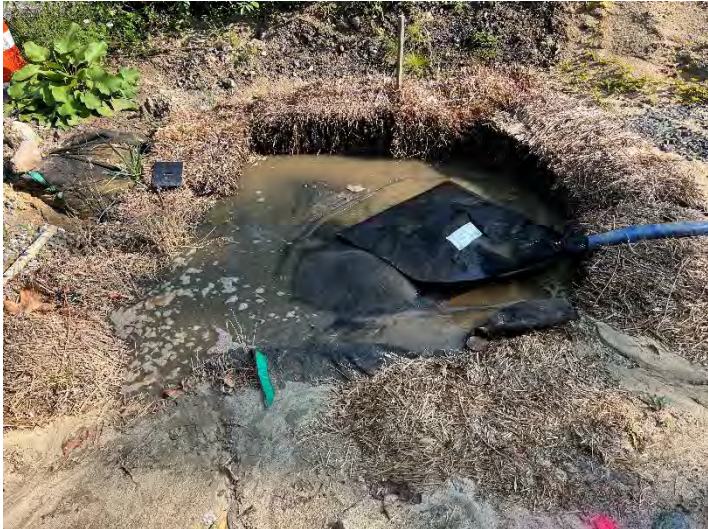
Description: View of discharging water within corral. Discharge appeared cloudy and turbidity reading was above 50 NTUs. Water was being discharged to catch basin underneath filter fabric. Facing north.

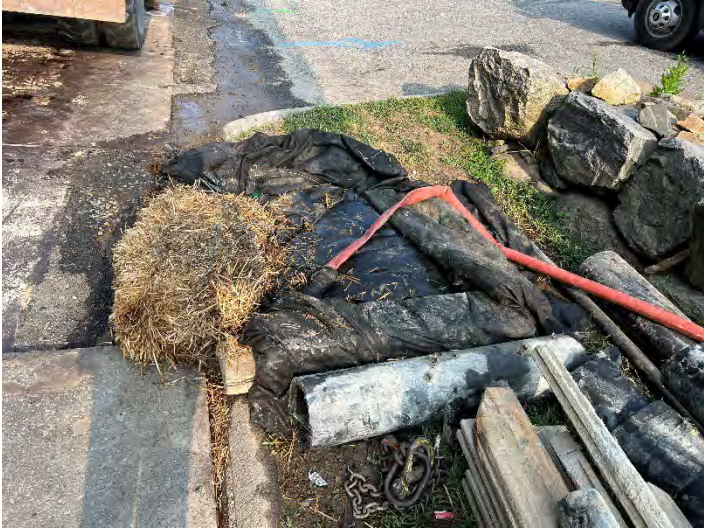
Description: View of dewatering controls (straw bale corral with filter fabric and silt bag). Facing west.

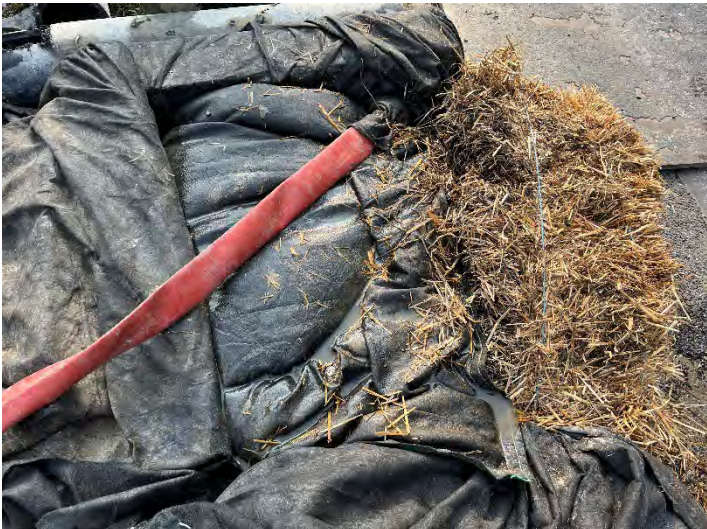
Description: View of discharging water within corral. Discharge appeared turbid and turbidity reading was above 50 NTUs. Water was being discharged to catch basin underneath filter fabric.
